State Environmental Quality Review
NEGATIVE DECLARATION
Notice of Determination of Non-Significance

The Port Washington Police District (District), as lead agency, is hereby issuing this Negative Declaration for the project known as Port Washington Police District New Police Headquarters (Proposed Action). The Proposed Action is an Unlisted action as that term is defined in SEQRA.

Proposed Action:	Port Washington Police District New Police Headquarters
Lead Agency:	Port Washington Police District
Proposed Action Site:	128 Main Street, 10 Mackey Avenue & 97, 99, 101, 103 & 105 Webster Avenue, Port Washington, NY, 11050 NCTM: Section 5 Block 38 Lots 8, 408-412 & 416-418
SEQRA Status:	Unlisted, Coordinated Review

Building Name:	Austin F. Knowles Funeral Home (Main Building)
Building Number:	128 Main Street, Port Washington, NY
Date Surveyed:	May 3, 2024 – Exterior, Basement & First Floor May 8, 2024 – Second Floor and Attic

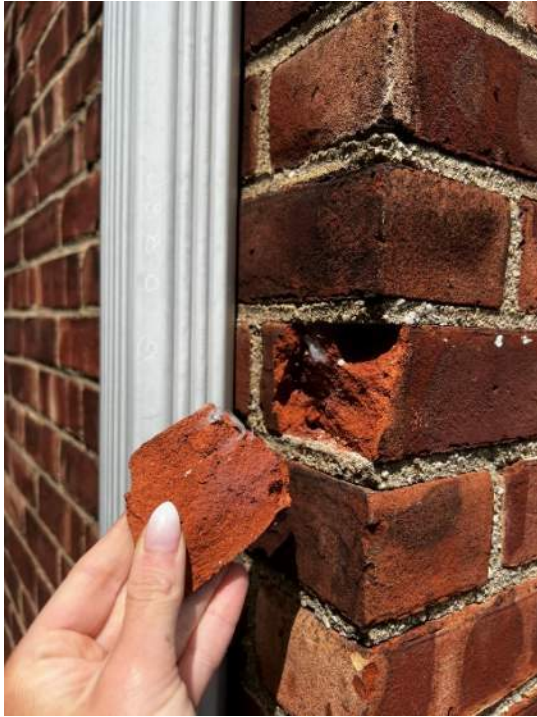
The south façade (rear) contains brick masonry with visible damage, including spalling and general damage and wear (photos 1, 2, 3 & 4). The painted wood trim has visible cracking and deterioration in certain areas. To prevent wood shrinkage, caulking is required. Additionally, the exterior doors and windows have lintels that are rusted.

PHOTO 1: IMG_1096 South East Corner – Damage from brick spalling and moisture infiltration

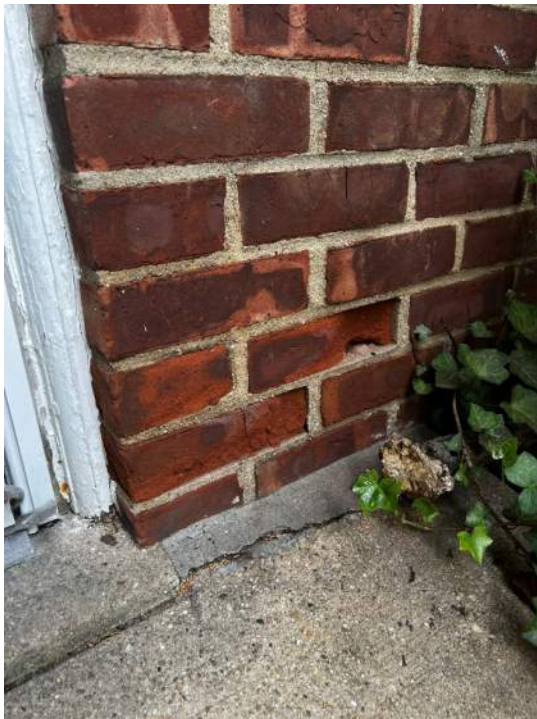
PHOTO 2: IMG_1101 South Façade – Wear on bricks, general staining

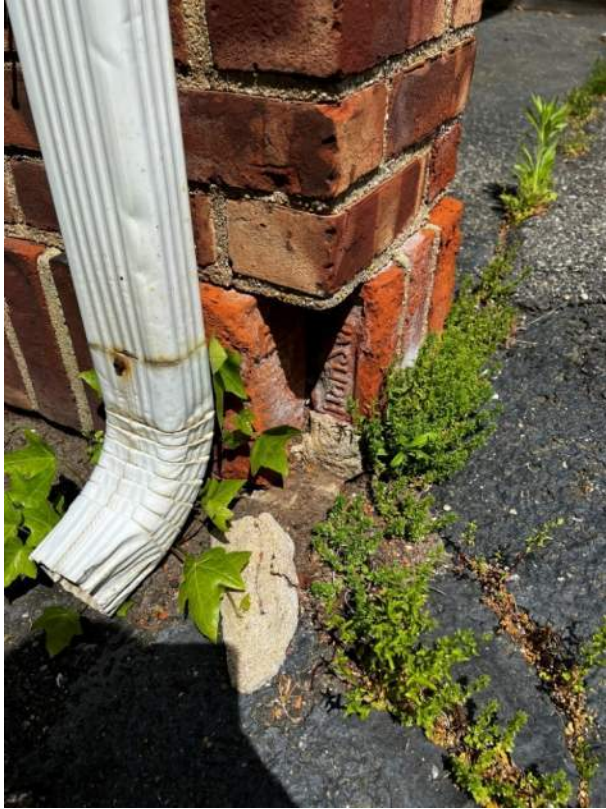
PHOTO 3: IMG_1097 South East corner – missing brick

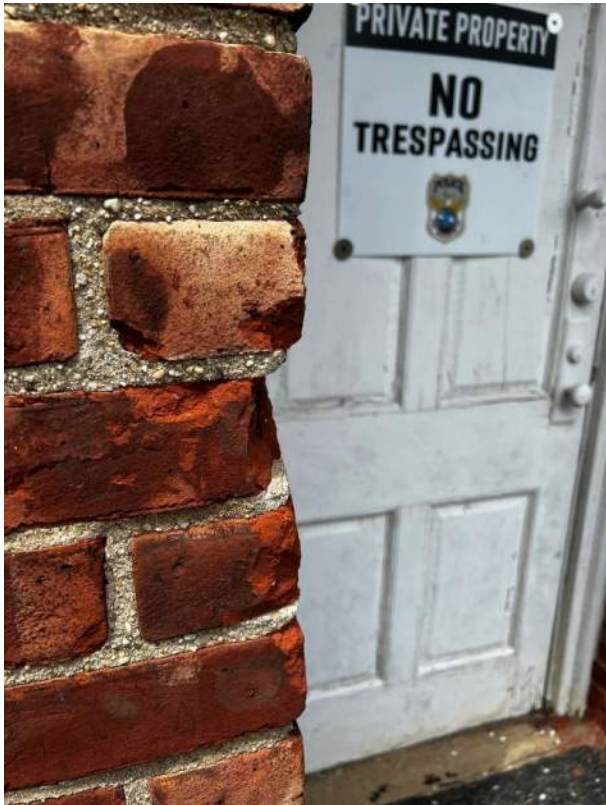
PHOTO 4: IMG_1092 – South East Corner – visible damage to brick masonry

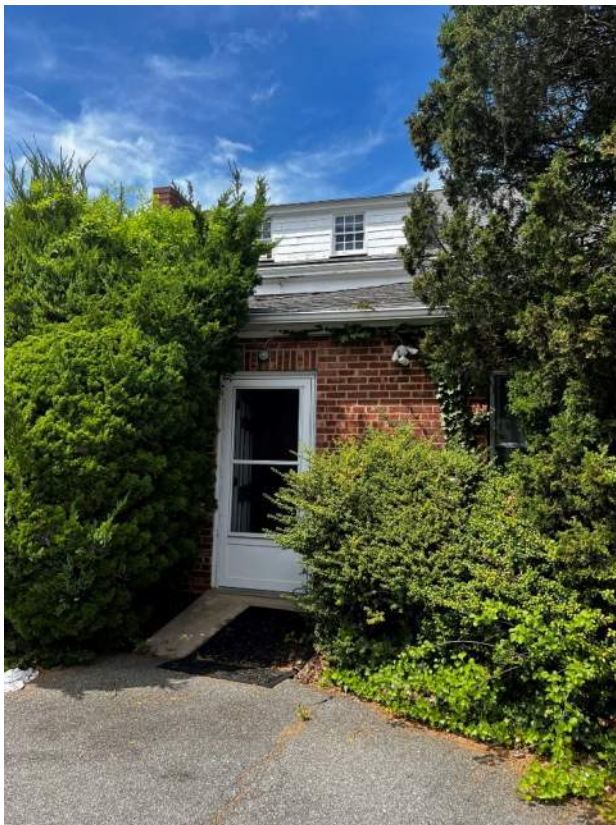
PHOTO 6: IMG_1104 – South Façade – Non-compliant ADA ramp top door, door swings in, rusting lintels.

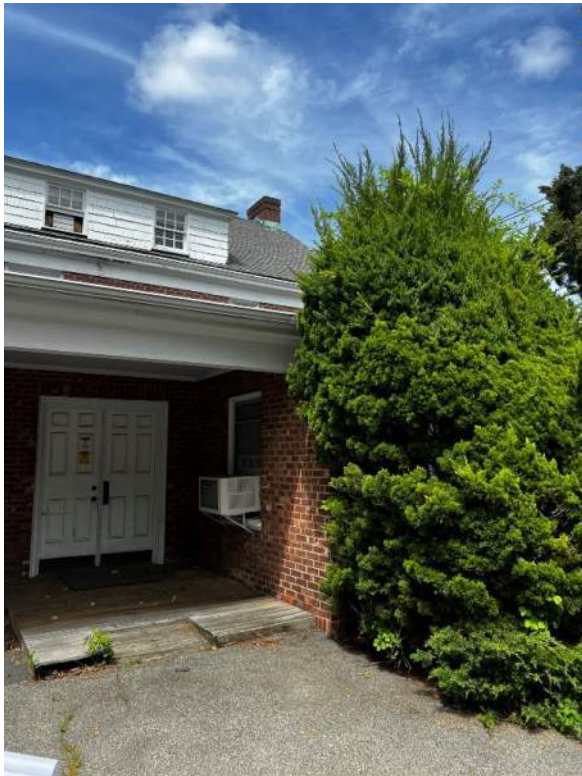
PHOTO 7: IMG_1090 – South Façade – Double doors with non-compliant ADA hardware.

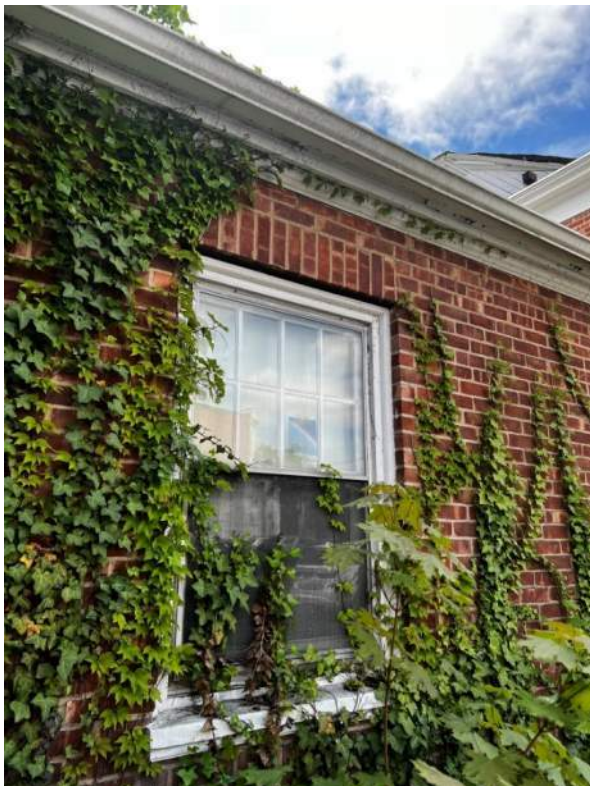
The exterior walls of the funeral home consist of wood stud construction with brick veneer. The exterior façade has significant mold, mildew, and ivy growth indicating trapped moisture (photos 8, 10, 19, & 20). The gutters are overgrown with ivy and clogged; the clogged gutters and mold and mildew growth has led to retained moisture, dislodging exterior brick.

PHOTO 8: IMG_1106 – East Façade – Ivy Growth on walls and gutters, rusted lintels, single pane glazing, wood sills and frame.

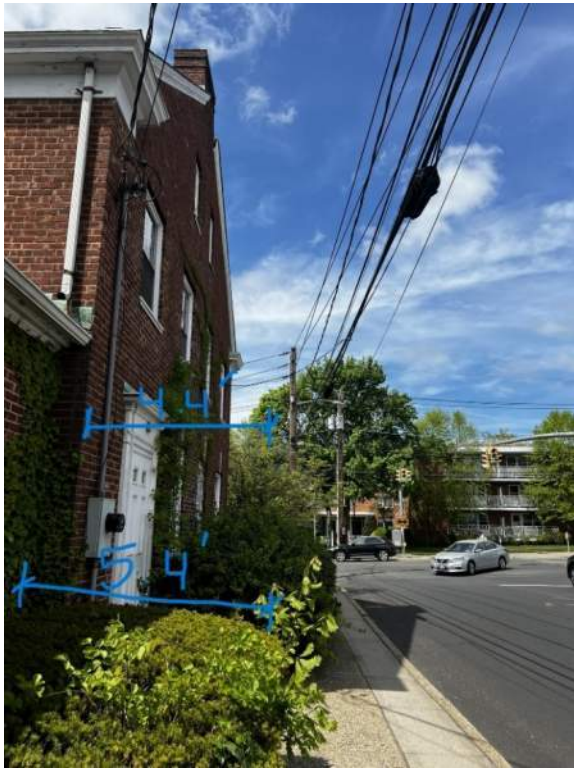
PHOTO 9: IMG_1107-(1) – East Façade – Building separation from property line.

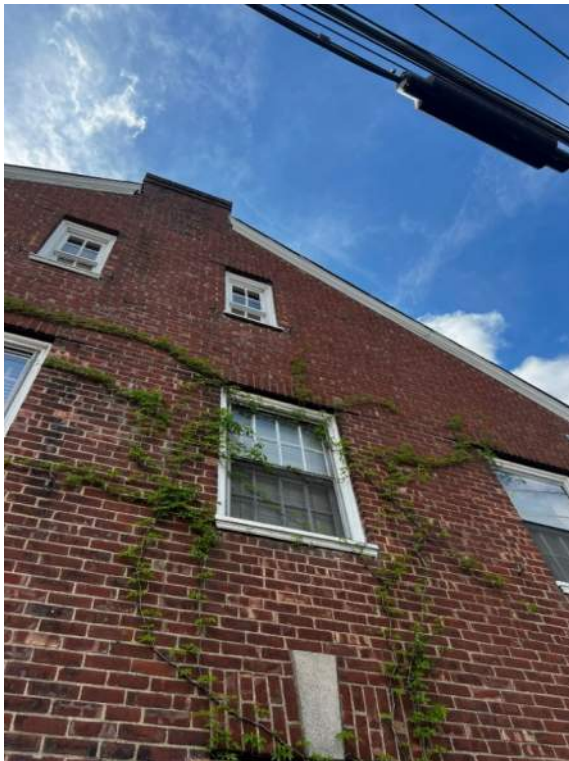
The east façade facing Mackey Avenue has significant wood deterioration at the exterior door trim and is missing entire pieces of trim (photo 12). The exterior wall contains significant bulging in brick, visually observed for three (3) second floor windows and two (2) attic windows (photos 10 & 11).

PHOTO 10: IMG_1131 – East Façade – Visible bulging of brick window headers (above lintels), refer to photo 82 for visible water damage at attic window headers.

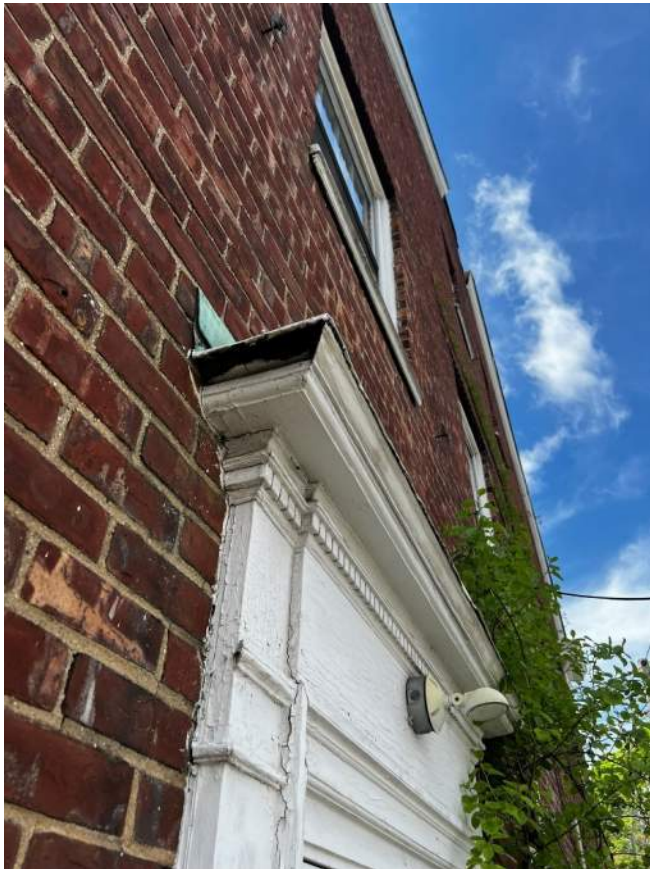
PHOTO 12: IMG_1049 – East Façade – deterioration of wood trim and missing pieces.

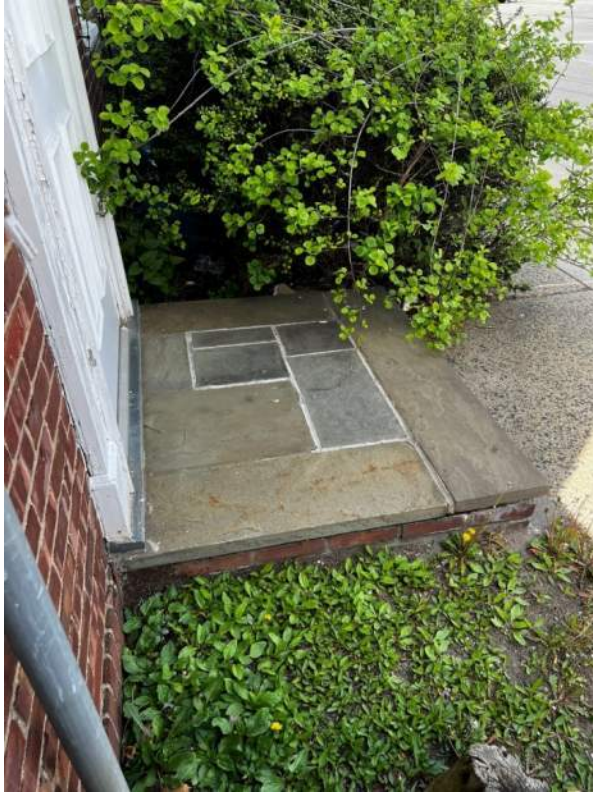
PHOTO 13: IMG_1017 – East Façade – Emergency exit door with non-compliant landing/elevation.

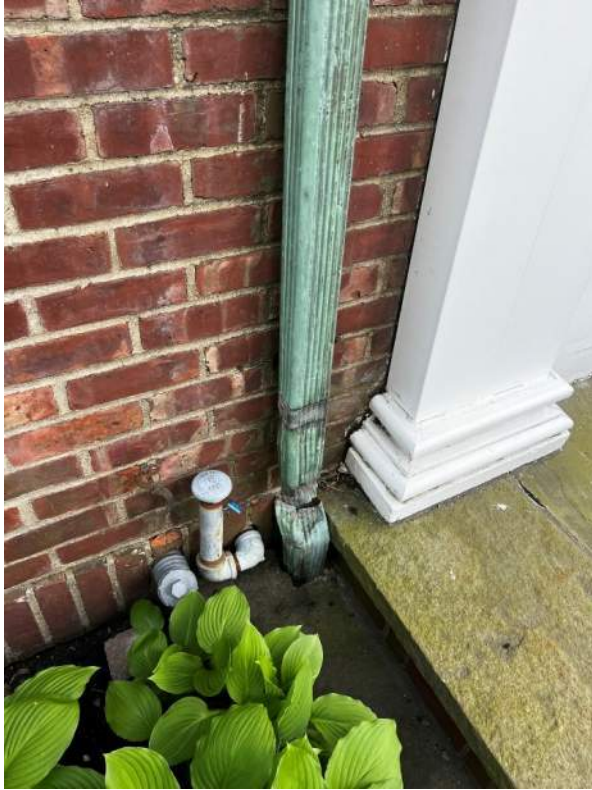
The painted wood façade elements on the North Façade (front) are chipping, exposing the wood to the elements, and the wood has begun to weather (photo 16). The exterior wall is missing a downspout causing water to drain directly onto the foundation wall (photo 15). Additionally, the internal downspout to collector

PHOTO 15: IMG_1147 – North Façade – Damaged downspout, allowing water to drain directly to foundation wall.

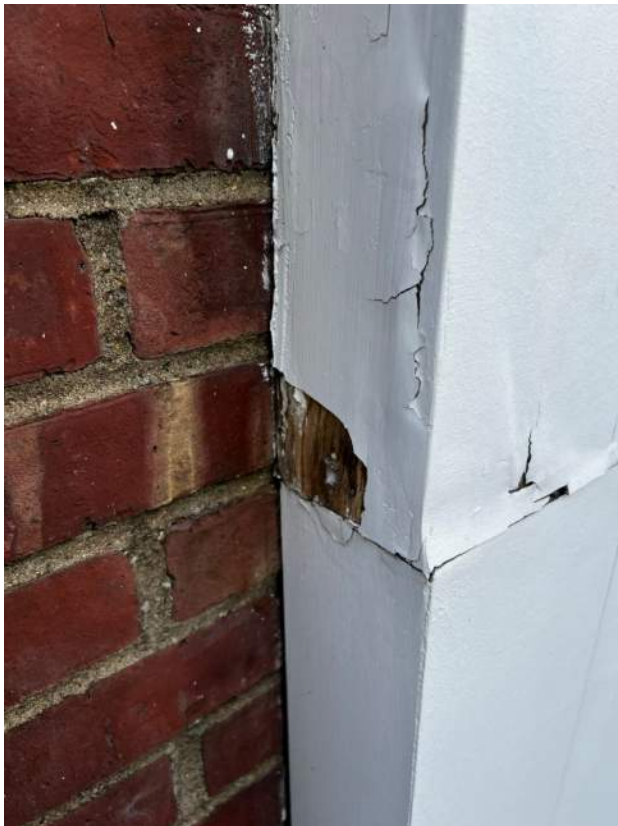
PHOTO 16: IMG_1148 – North Façade – Painted wood façade elements are chipping, exposing the wood to the elements. Wood has begun to weather.

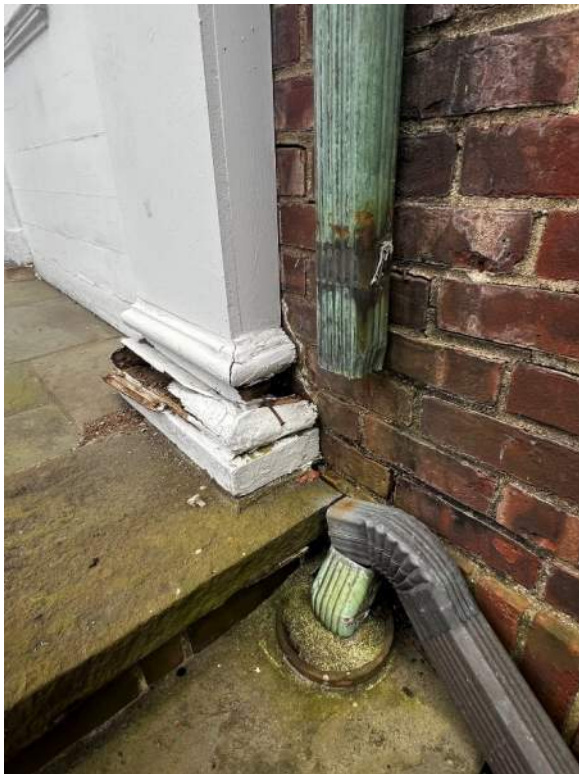
PHOTO 18: IMG_1327 – North Façade (North West of front entrance) - Internal downspout to collector box is dislodged, allowing water to drain onto brick masonry and wooden elements. Significant deterioration of wooden pilasters and trim at front entry.

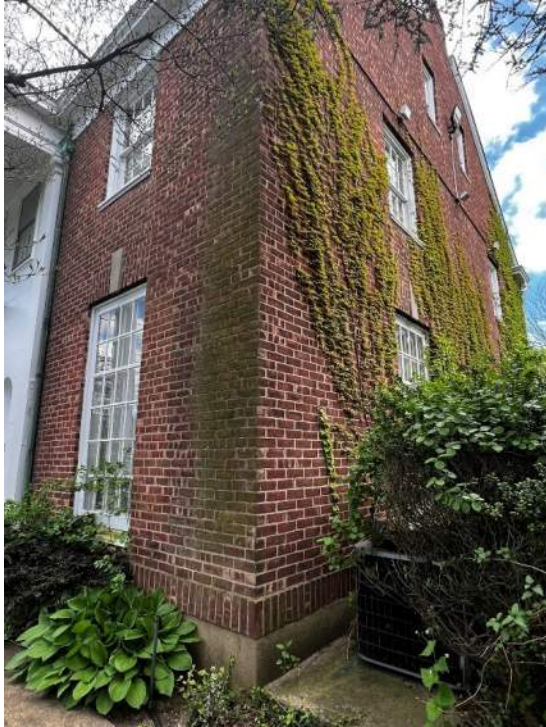
PHOTO 19: IMG_1325 – North West Corner – Significant mold and mildew on North Façade. Significant ivy growth which should be removed on West facade.

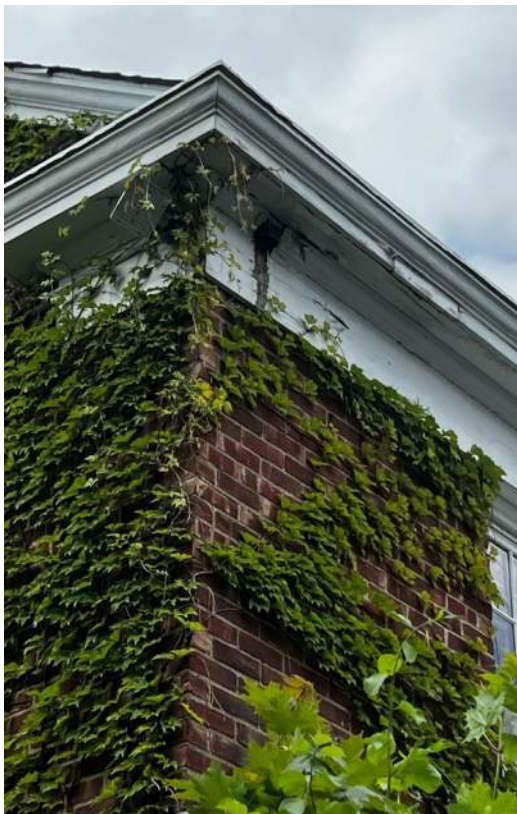
PHOTO 22: IMG_1313 – South Façade - Missing downspout, significant deterioration of wood fascia, rake boards and soffit.

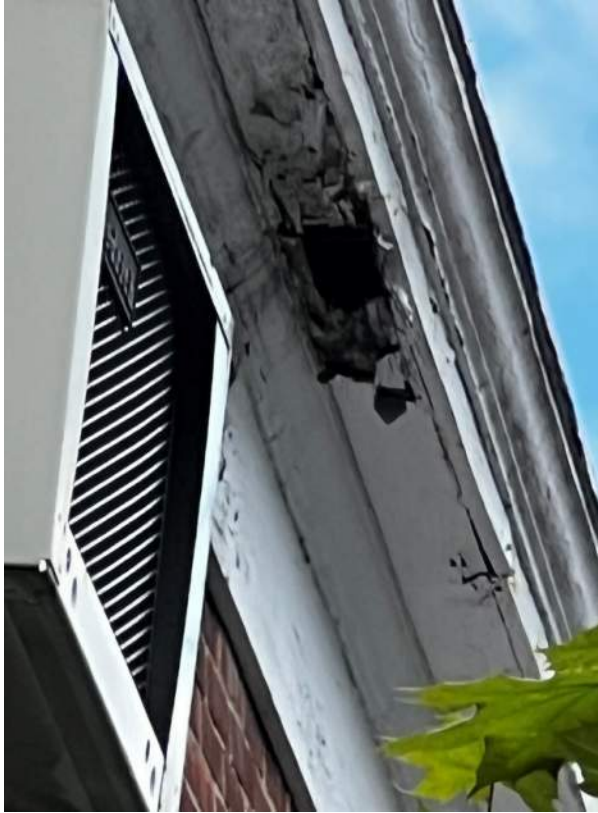
PHOTO 23: IMG_1313 – Missing downspout, significant deterioration of wood fascia, rake boards and soffit.

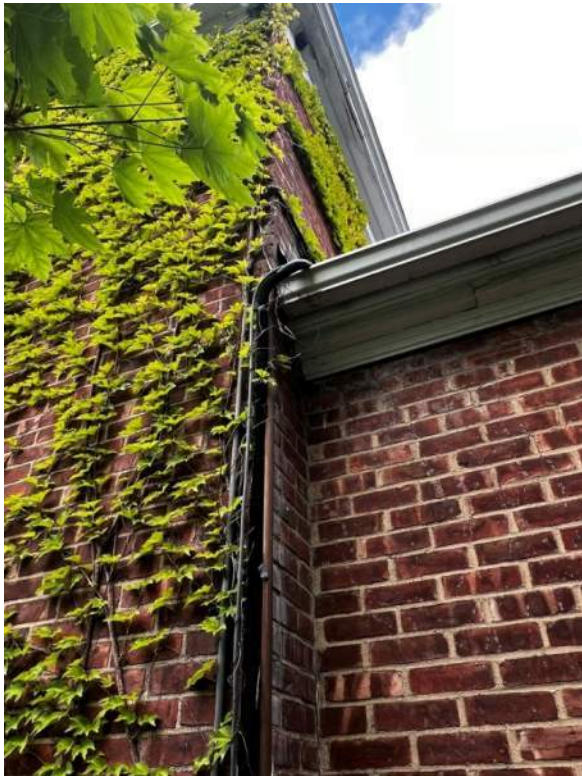
Photo 24: IMG_1350 - West Façade – Visible efflorescence at inside brick corner. Significant water damage at interior side of inside corner.

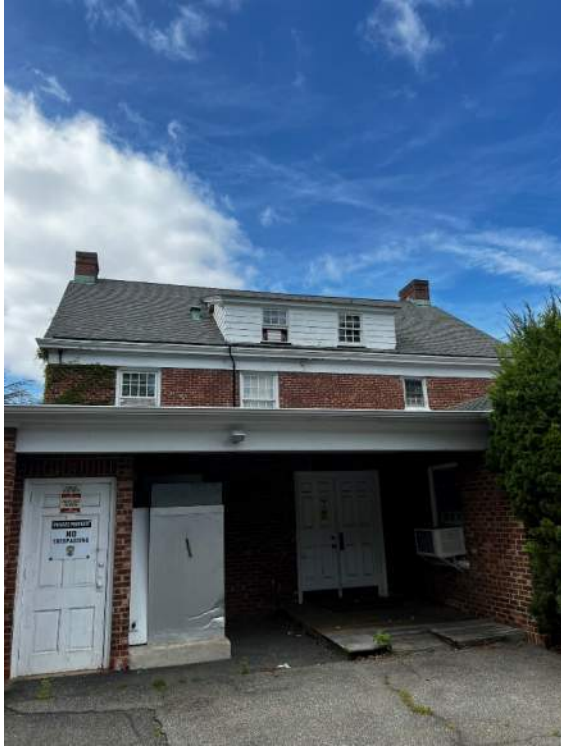
Photo 25: IMG_1351 - South Facade – No visible flashing from reverse gable roof to second story brick masonry wall. Damage to cedar shake at attic dormer.

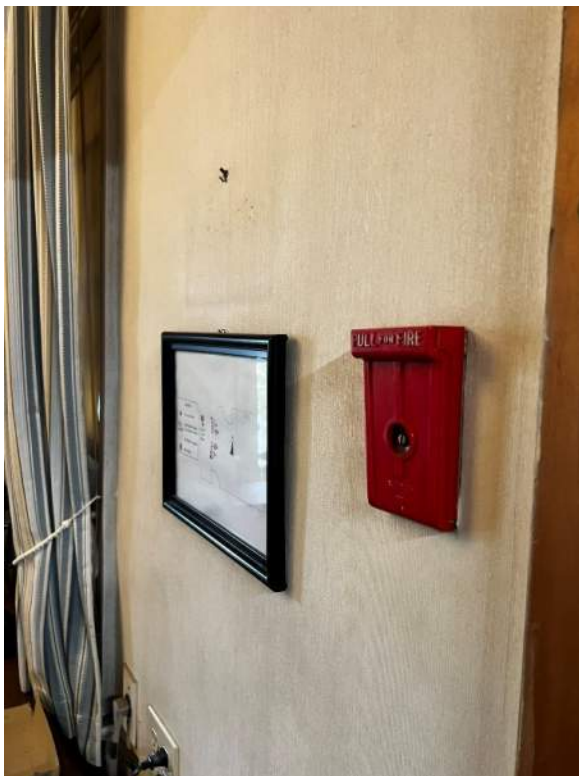
Photo 26: IMG_1170 - Interior 1st Floor, Rear Office – Non-functioning pull stations.

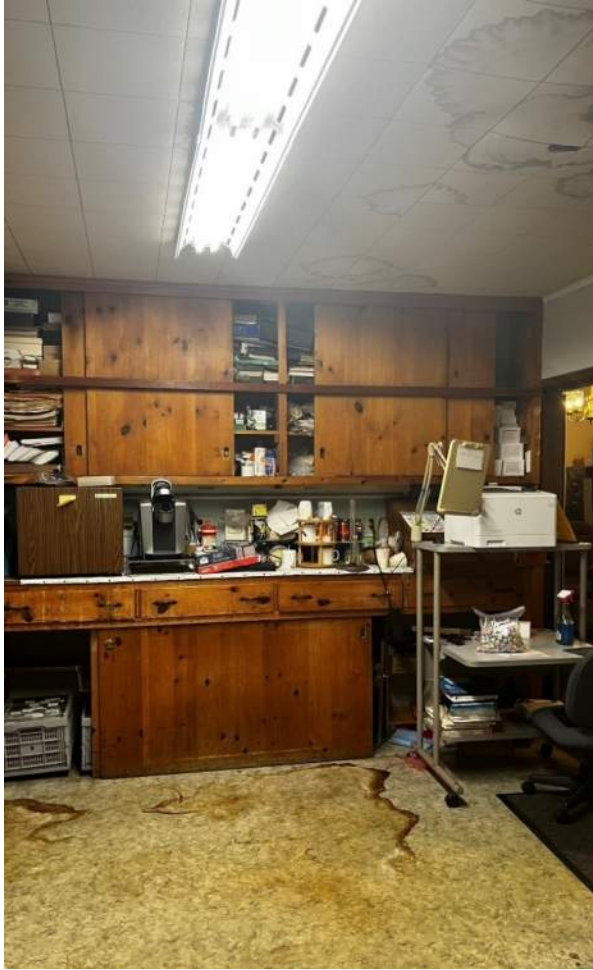
Photo 28: IMG_1426 - Interior 1st Floor, Anteroom to Prep Room – Significant water damage to the ceiling finish, including ceiling staining, wet ceiling tiles, present puddles and staining at floor.

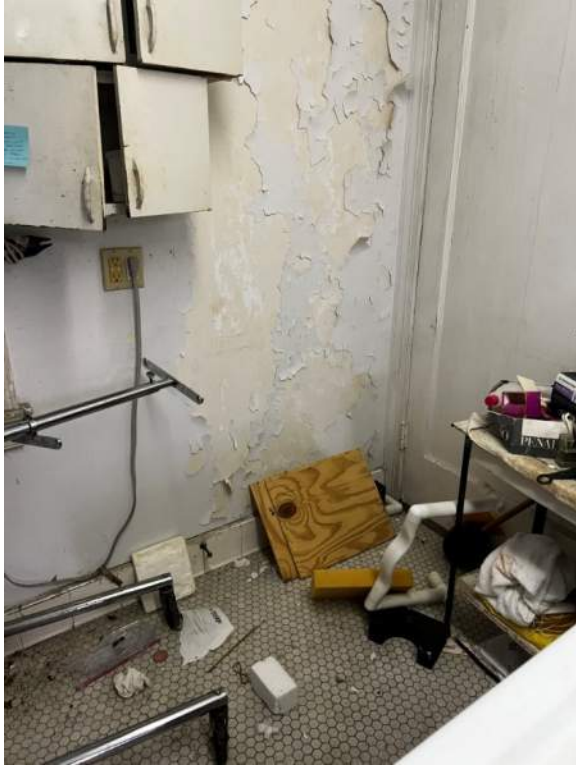
Photo 29: IMG_1183 - Interior 1st Floor, North West corner of Prep Room – significant water damage for full height of interior corner and ceiling.

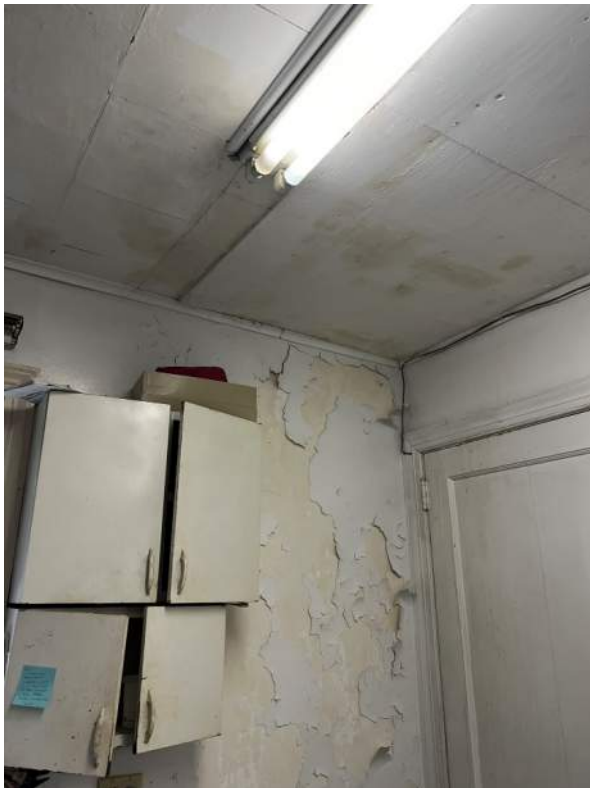
Photo 30: IMG_1182 - Interior 1st Floor, Northwest corner of Prep Room – significant water damage for full height of interior corner and ceiling.

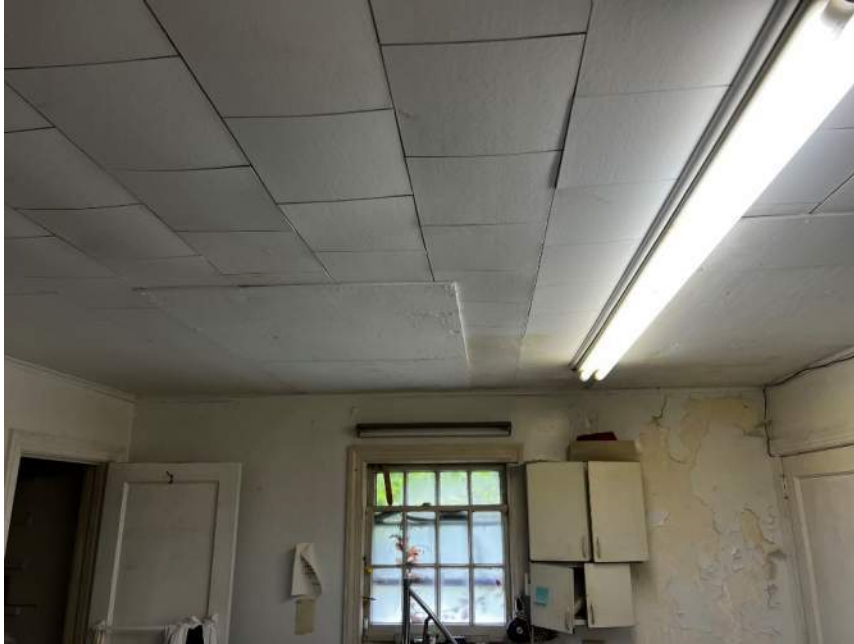
Photo 31: IMG_1191 - Interior 1st Floor, Prep Room – Prep Room ceiling exhibits visible sagging with patching (Photo 31). Evident ponding on roof above and surrounding areas infers water infiltration issues (photo 68).

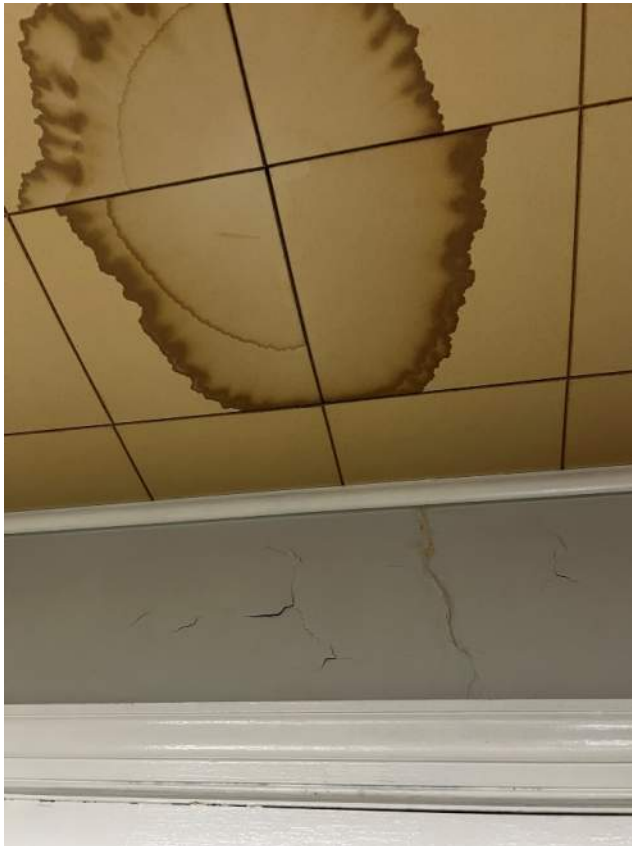
Photo 32: IMG_1197 - Interior 1st Floor, Anteroom to Prep Room – Visible water damage to ceiling started infiltrating wall.

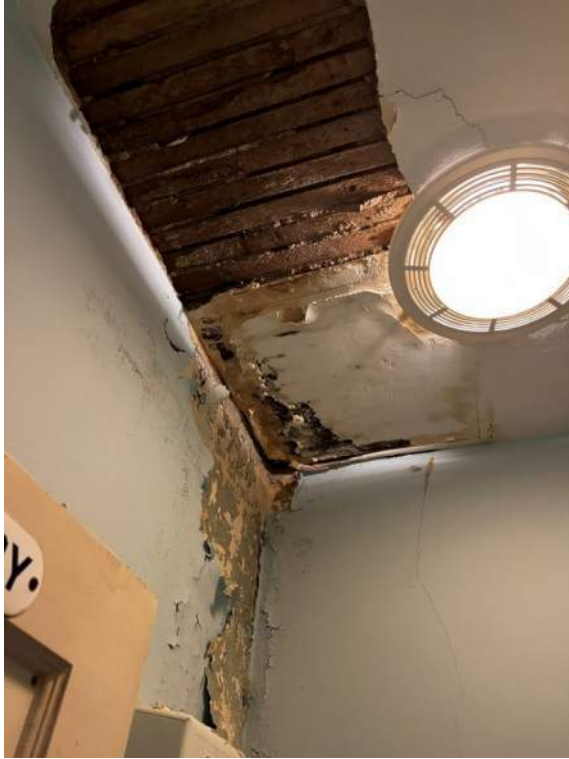
Photo 33: IMG_1207 - Interior 1st Floor, Gender Neutral Lavatory (North) – Water damage has caused significant ceiling disintegration and damage to original lath and plaster ceiling.

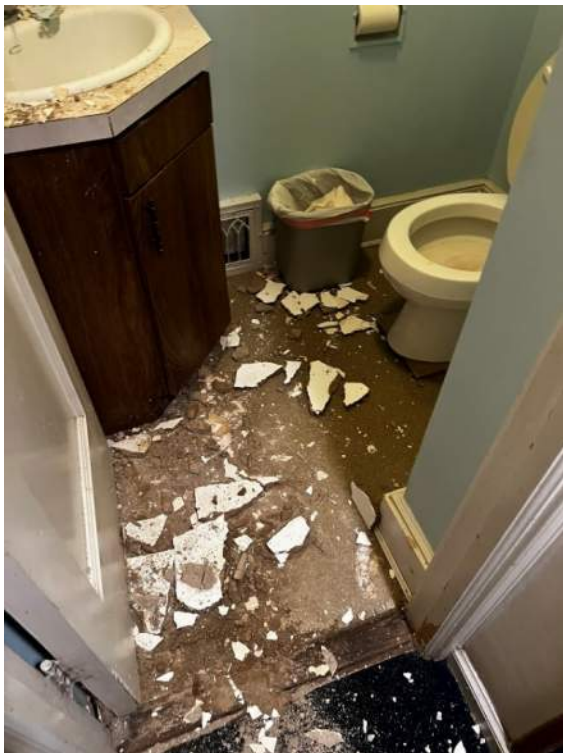
Photo 34: IMG_1205 - Interior 1st Floor, Gender Neutral Lavatory (North) – Water damage has caused significant ceiling disintegration and damage to original lath and plaster ceiling. Toilet room is not ADA compliant.

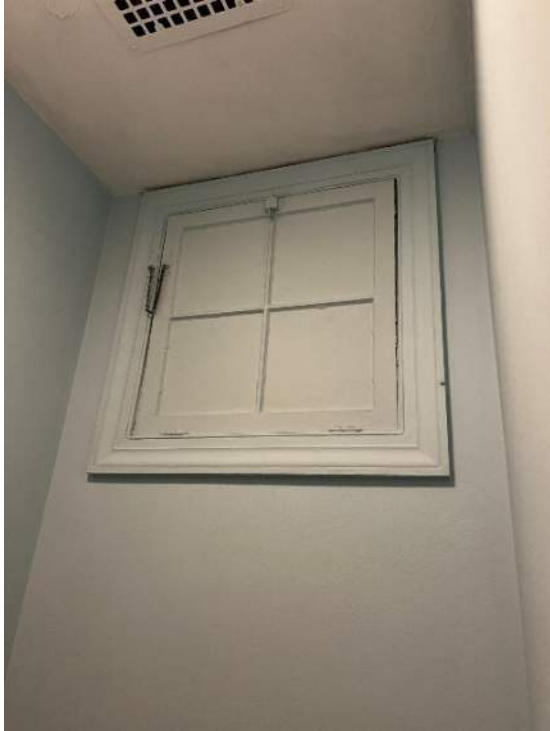
Photo 35: IMG_1208 - Interior 1st Floor, Gender Neutral Lavatory (North) – Operable window opens to interior framing. Indicates possible reconstruction or additions of existing building.

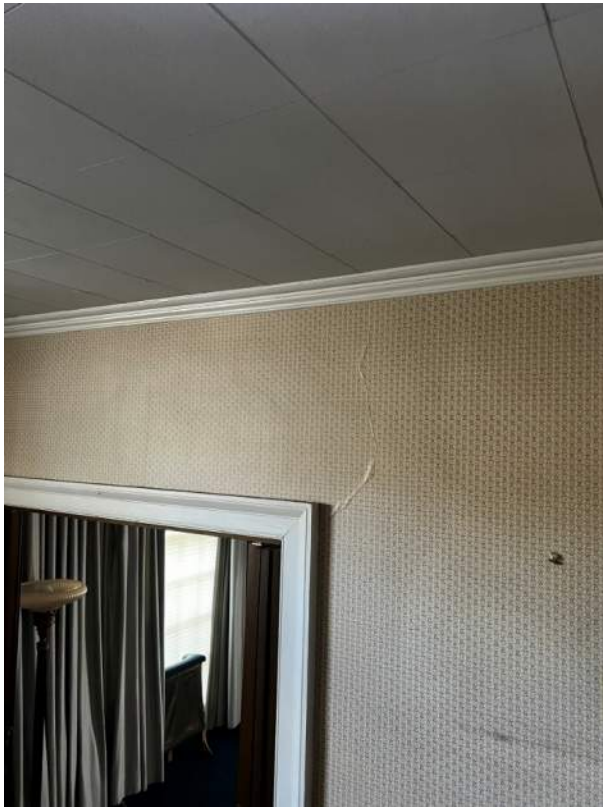
Photo 40: IMG_1224 - Interior 1st Floor Main Entrance – Wall cracking is present below wallcovering finish.

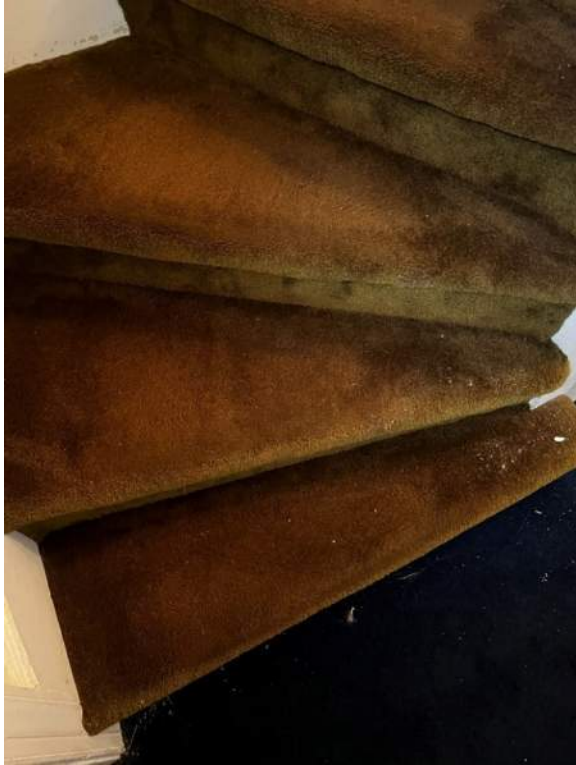
Photo 41: IMG_1237 - Interior 1st Floor East side egress stair – Contains winder treads.

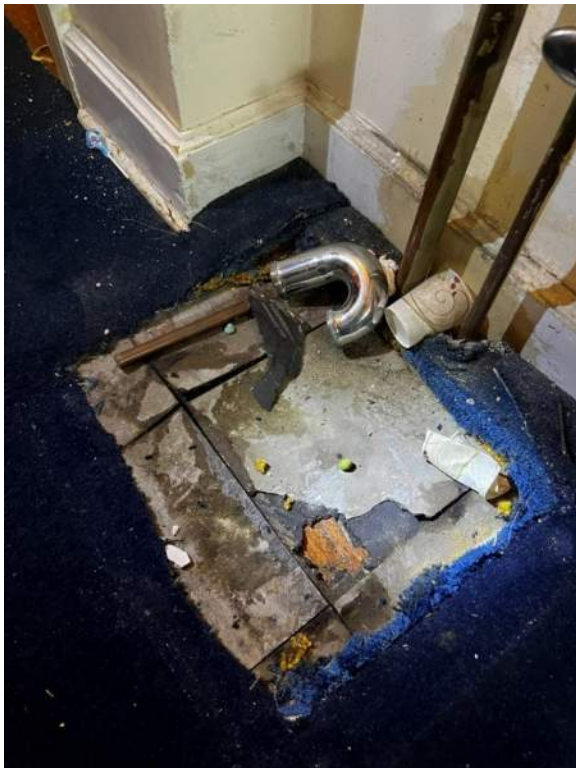
Photo 42: IMG_1241 - Interior 1st Floor West side hallway to West emergency exit – Water fountains have been removed. Evident water damage at area of removal.

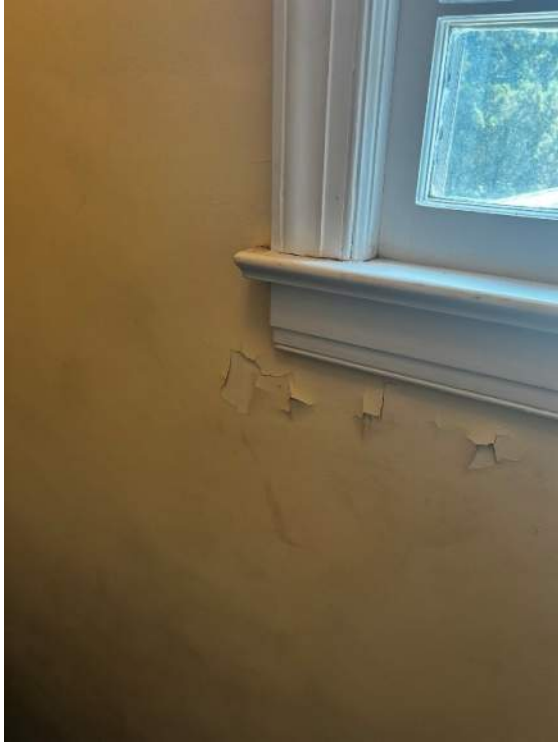
Photo 45: IMG_1430 - East side egress stair, top landing – Plaster wall finish is chipping and peeling from evident water infiltration and moisture into wall finish.

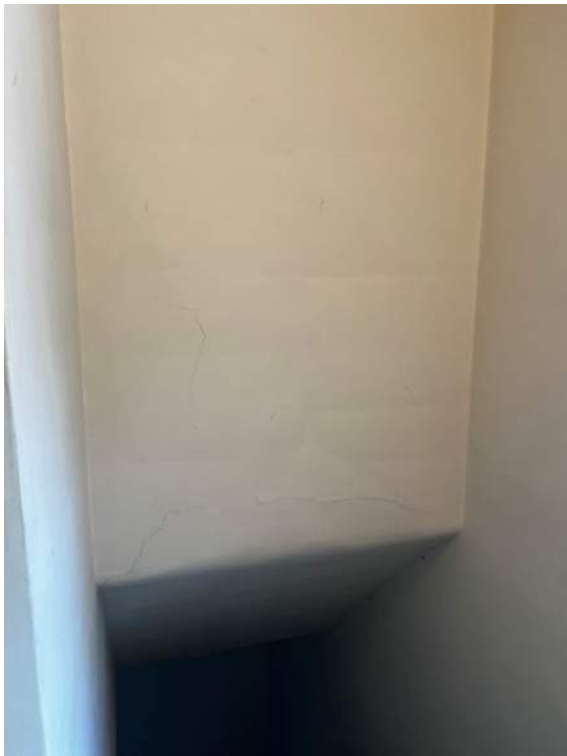
Photo 46: IMG_1428 - East side egress stair, top landing – Plaster wall finish beginning to crack, bulge and bow at area above stairs. Requires refinishing.

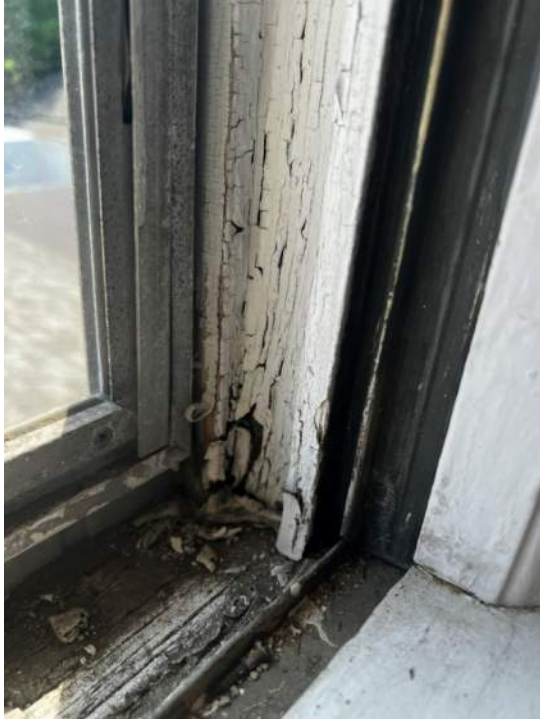
Photo 47: IMG_1435 - East side egress stair, top landing – Window is operable. Interior jambs of window are exhibiting deterioration of paint finish and wood below. Aluminum storm screen can be seen.

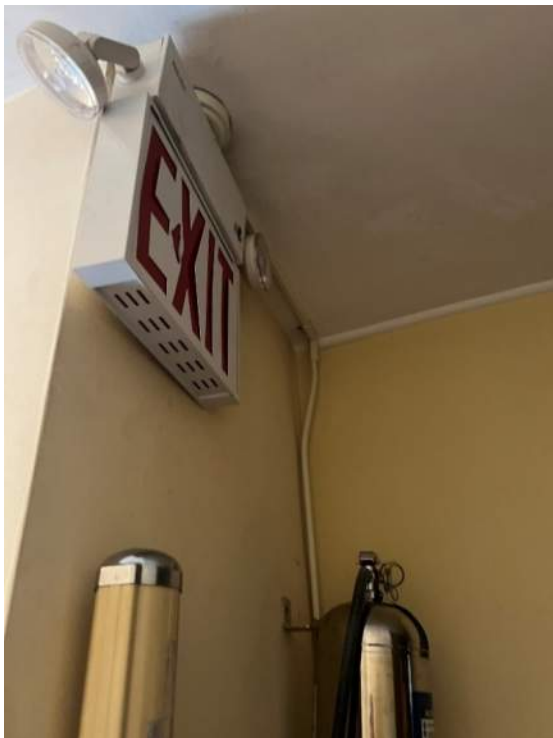
Photo 48: IMG_1438 – Second Floor Hallway to East side egress stair. Emergency exit sign is present, but not continuously illuminated with active power to building.

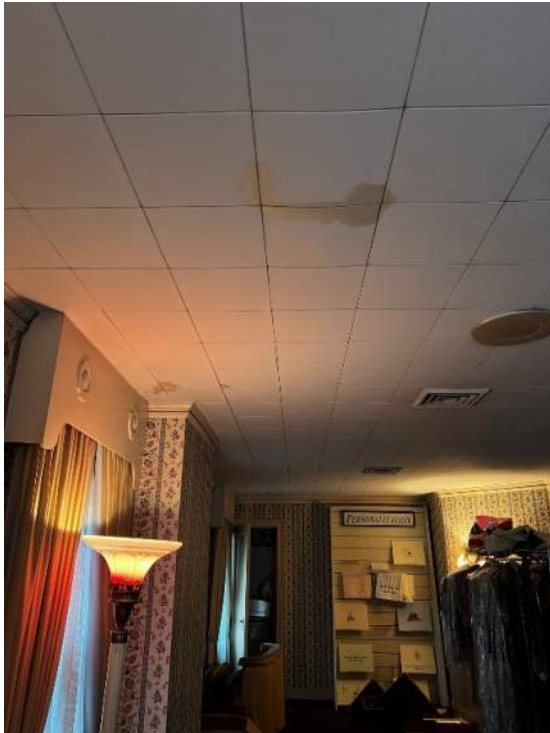
Photo 57: IMG_1466 – Second Floor East Chapel – Visible water damage and active leak at ceiling. Ceiling stain is wet to the touch.

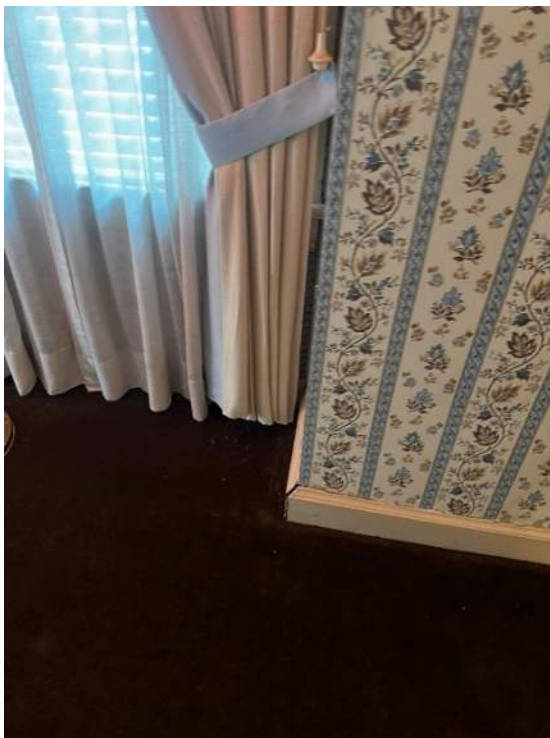
Photo 58: IMG_1473 – Second Floor East Chapel – Chimney exhibits visible bowing with subsequent damage to the baseboard trim from the masonry movement.

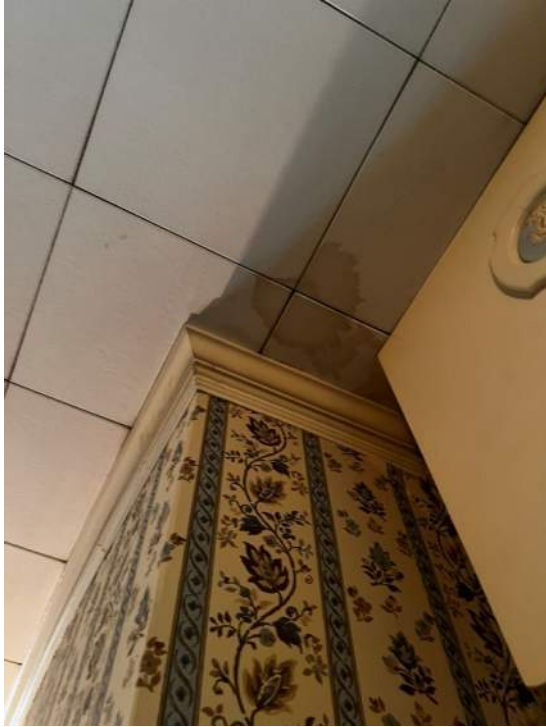
Photo 59: IMG_1475 – Second Floor East Chapel – Leaks evident at ceiling on both sides of the chimney enclosure.

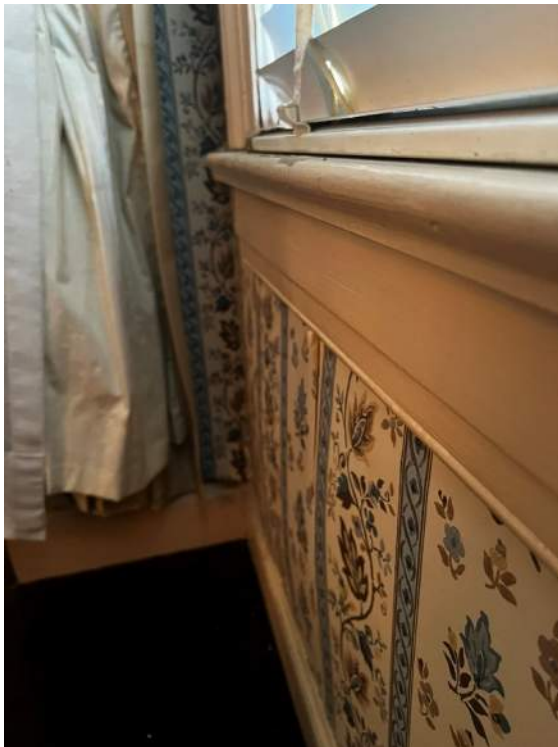
Photo 60: IMG_1476 – Second Floor East Chapel – Walls below East windows exhibiting bowing due to water infiltration.

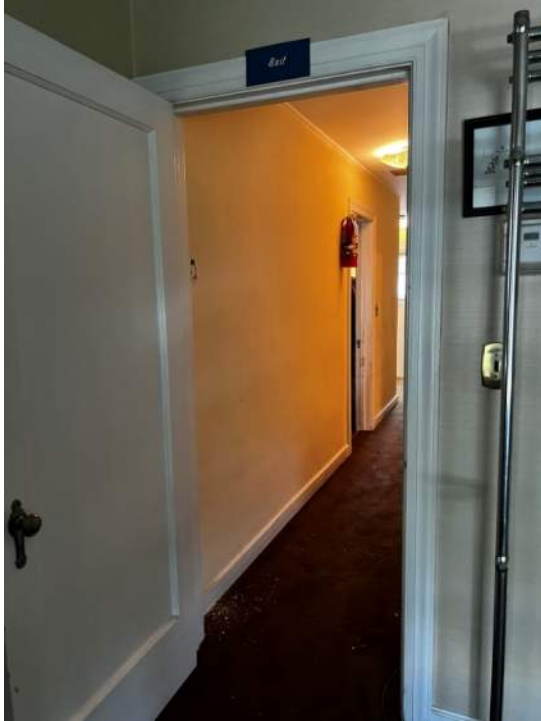
Photo 61: IMG_1487 – Second Floor North Anteroom – Non-compliant illuminated directional exit signage. Non-compliant door hardware for ADA compliance. Fire extinguisher is not mounted in compliance with NFPA 10. If mounted in compliance with NFPA 10, fire extinguisher would be non-compliant with ADA for protruding objects and would reduce the minimum required clear width of the hallway.

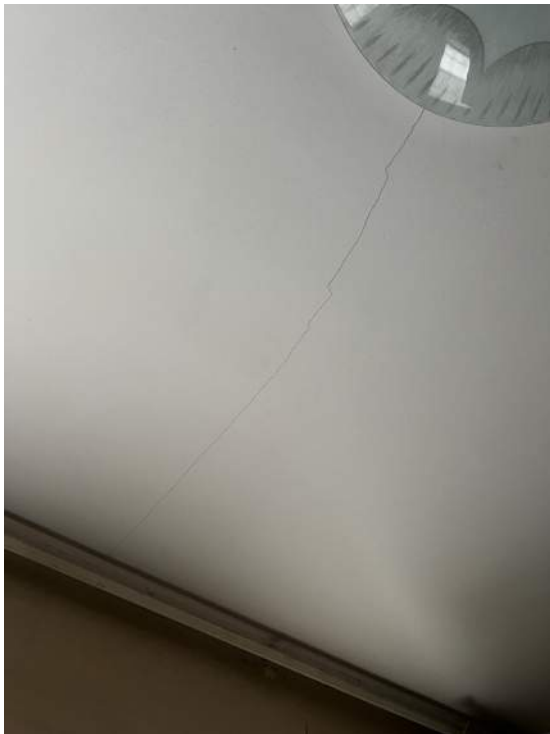
Additionally, the ceiling exhibits cracking due to the deflection of the wood framing (photo 62).

Photo 62: IMG_1489 – Second Floor North Anteroom – Ceiling exhibits cracking due to deflection of wood framing.

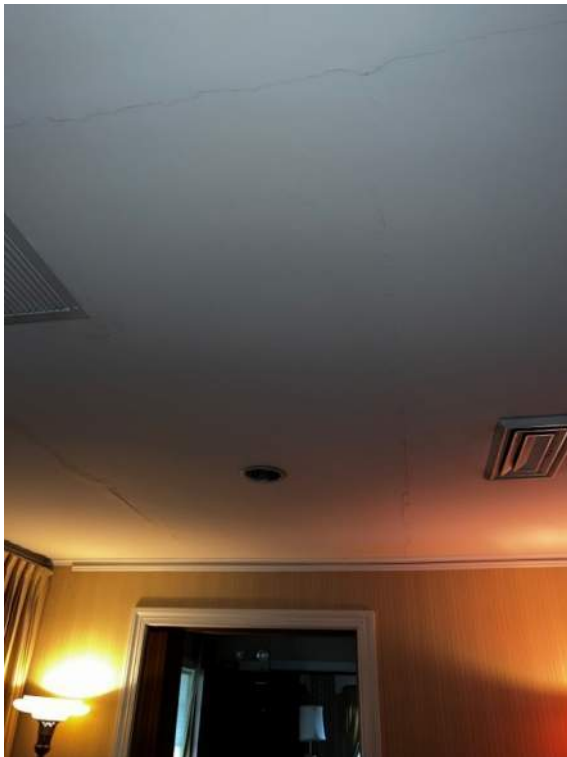
Photo 64: IMG_1495 – Second Floor Northwest Chapel – Ceiling exhibits cracking due to deflection of wood framing. Cracks in ceiling run full length and width of room. Building does not contain emergency egress lights; main source of illumination is portable lamps.

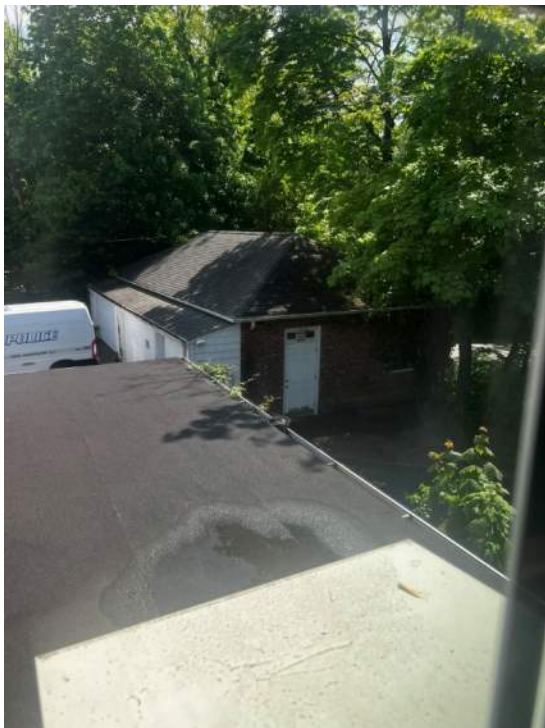
Photo 68: IMG_1517 – Flat roof over rear – exhibits significant ponding on Northwest corner of roof; aligning with deteriorated wall and ceiling of Prep Room below.

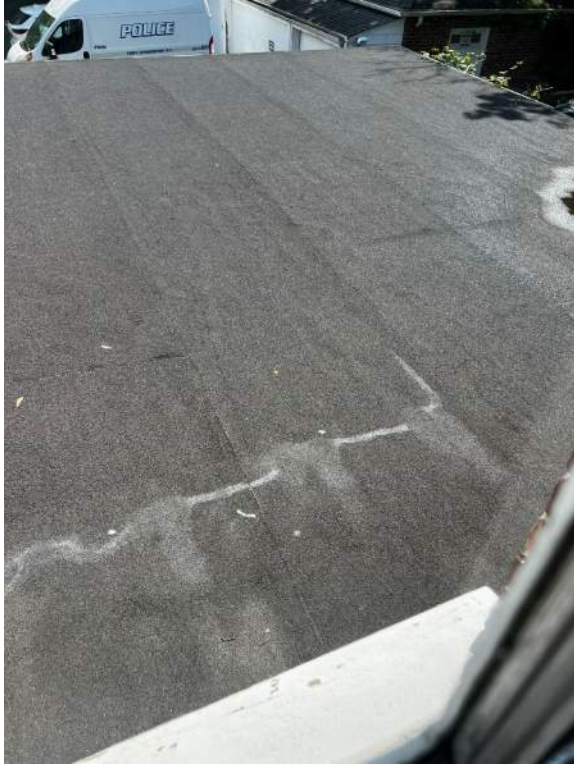
Photo 69: IMG_1518 – Flat roof over rear – Visible efflorescence staining and watermarks on roof surface.

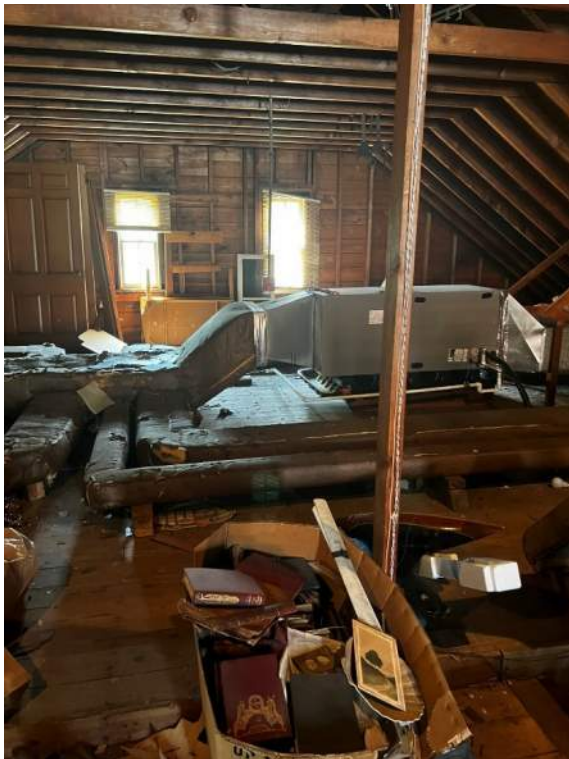
Photo 70: IMG_1597 – Attic appliances – Attic does not contain a clear passageway for removal of the largest appliance; passageway is obstructed by ductwork and dunnage.

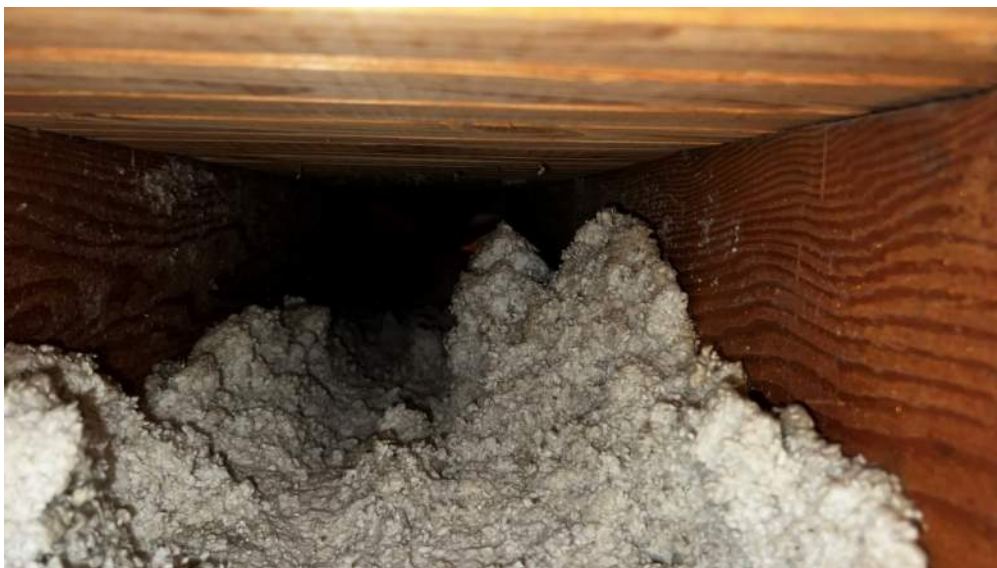
Photo 72: IMG_1534 – Non-compliant loose fill insulation per 2020 ECCNYS between 2x10 floor joists. Insulation values are not marked.
