State Environmental Quality Review
NEGATIVE DECLARATION
Notice of Determination of Non-Significance

The Port Washington Police District (District), as lead agency, is hereby issuing this Negative Declaration for the project known as Port Washington Police District New Police Headquarters (Proposed Action). The Proposed Action is an Unlisted action as that term is defined in SEQRA.

Proposed Action:	Port Washington Police District New Police Headquarters
Lead Agency:	Port Washington Police District
Proposed Action Site:	128 Main Street, 10 Mackey Avenue & 97, 99, 101, 103 & 105 Webster Avenue, Port Washington, NY, 11050 NCTM: Section 5 Block 38 Lots 8, 408-412 & 416-418
SEQRA Status:	Unlisted, Coordinated Review

Building Name:	Austin F. Knowles Funeral Home (Main Building)
Building Number:	128 Main Street, Port Washington, NY
Date Surveyed:	May 3, 2024 – Exterior, Basement & First Floor May 8, 2024 – Second Floor and Attic

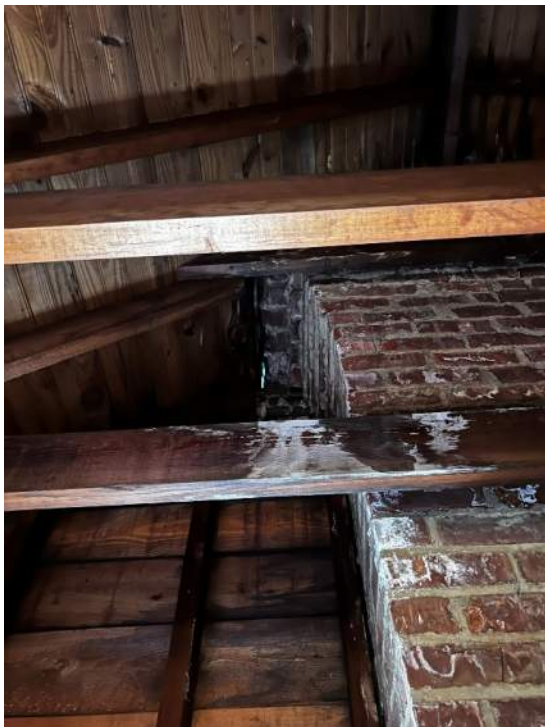
Photo 78: IMG_1575 – East Chimney – Chimney structure is corbelled with significant cantilevered bricks. Visible light between roof framing and chimney representing roof is not fully enclosed for protection from elements. Significant evidence of water infiltration, brick efflorescence on chimney with evident transfer to surrounding wood structure.

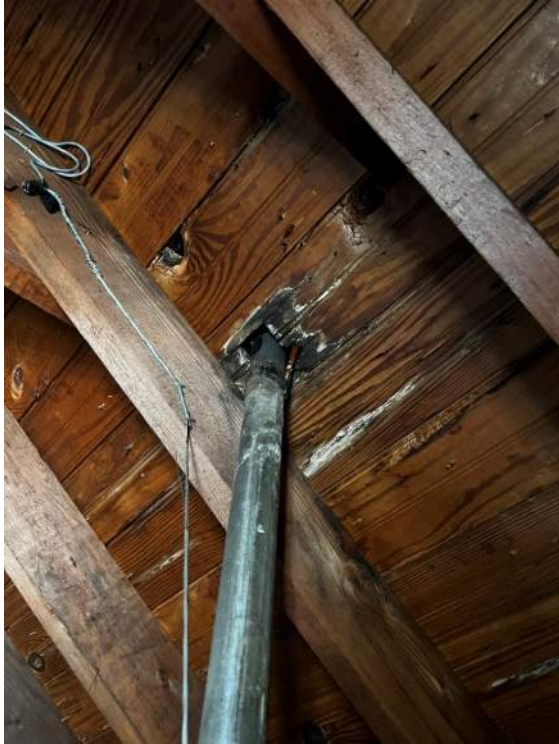
Photo 79: IMG_1576 – Roof Deck – Visible rot and moisture infiltration at roof deck surrounding plumbing vent stack indicating inadequate flashing.

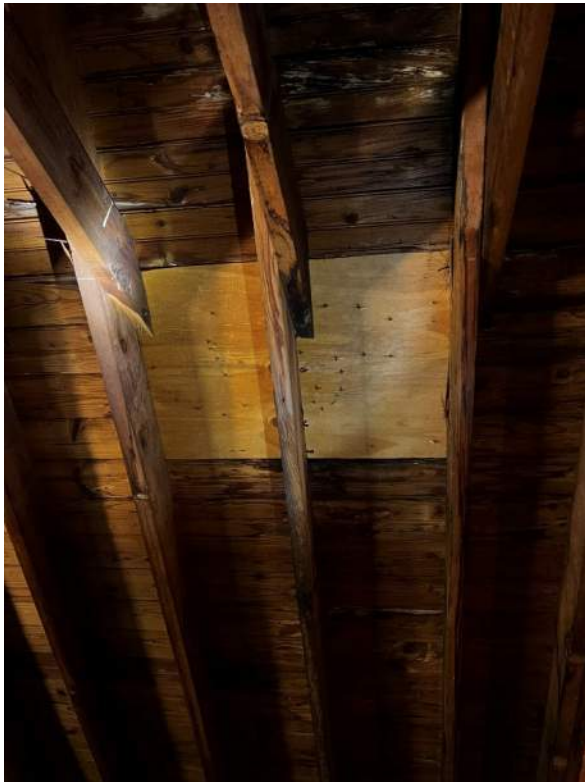
Photo 80: IMG_1577 – Roof Deck – Areas of roof deck have been replaced. Review of asphalt shingle roof is recommended.

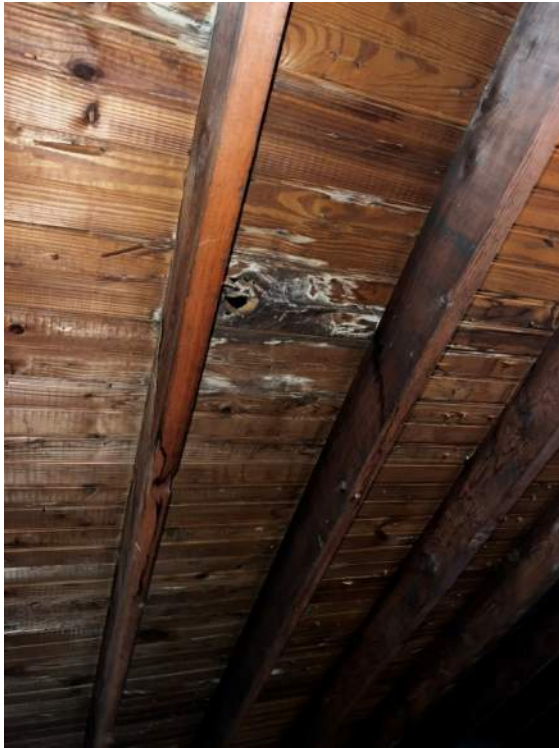
Photo 81: IMG_1601 – Roof Deck – Visible rot and moisture infiltration at roof deck in Northeast portion of attic.

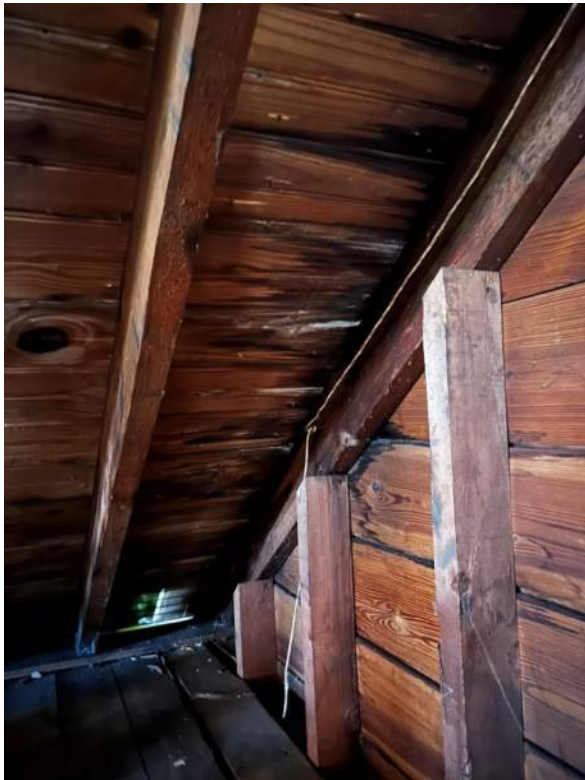
Photo 86: IMG_1563 – Visible water infiltration and moisture damage to roof decking and gable end wall.

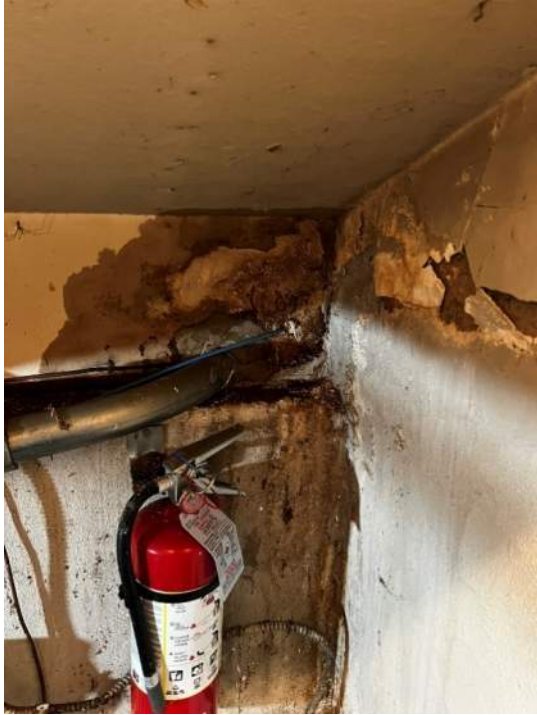
Photo 87: IMG_1242 – Visible water infiltration and moisture damage at inside corner of foundation wall and incoming conduit penetration. Plaster finish on foundation wall exhibits large chips and cracks from moisture.

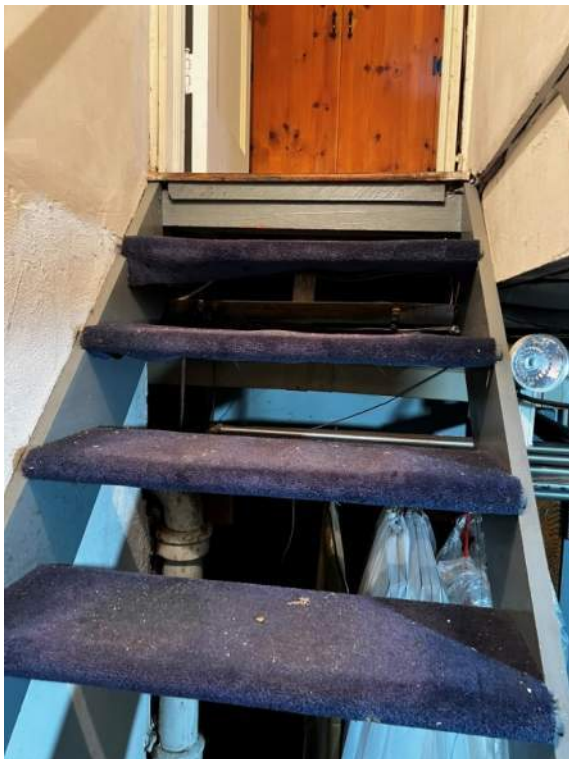
Photo 88: IMG_1244 – Basement egress stairs non-compliant with 2020 BCNYS and are not ADA compliant. Stairs feature non-complaint handrails, open stair treads, and are not enclosed with an exit at an exit discharge or to a public way.

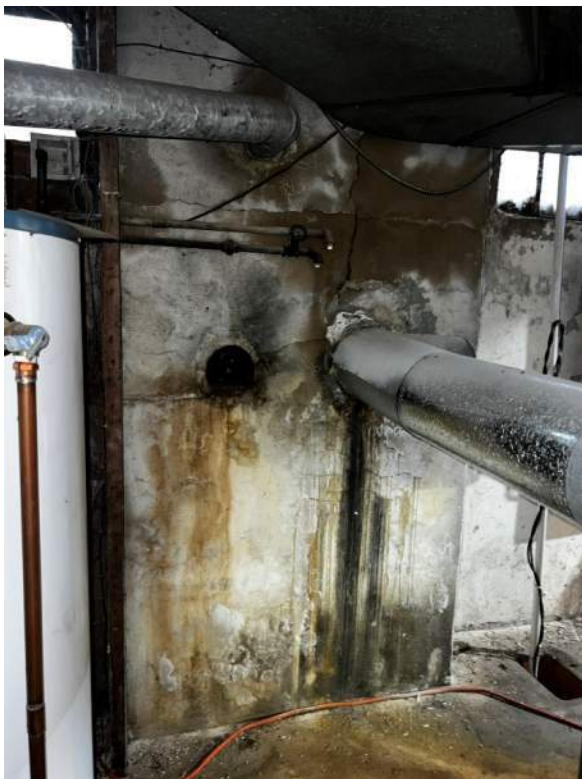
Photo 92: IMG_1256– Significant water damage and staining is present on interior side of East chimney foundation. Foundation for chimney is spalling and contains major vertical and horizontal cracking

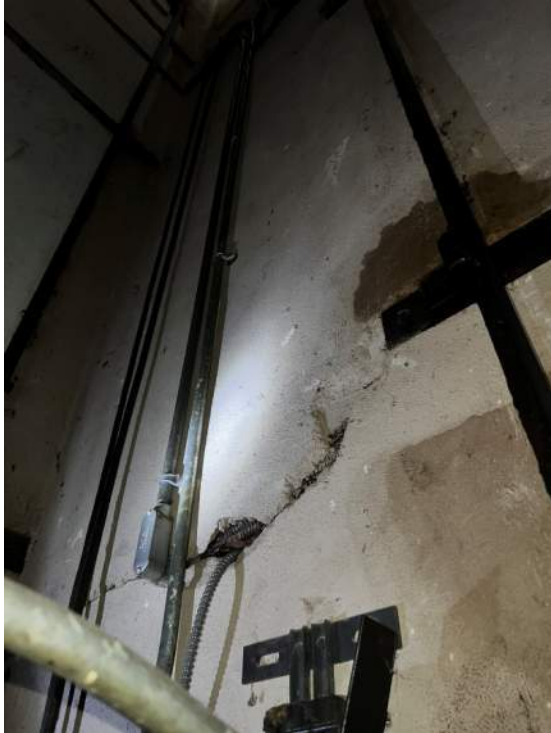
Photo 93: IMG_1251– Elevator shaft at Basement Level – Contains significant cracks and pipe penetrations that are not sealed as required for 2-hr fire rating at shaft way.

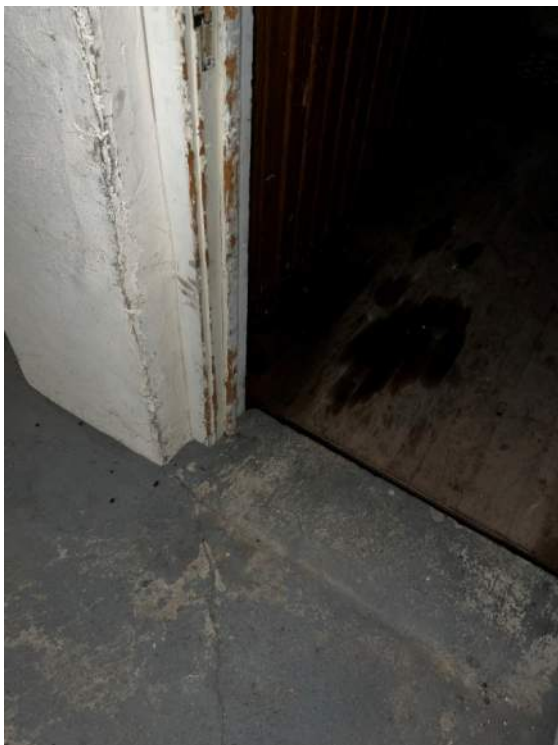
Photo 94: IMG_1651– Elevator shaft at Basement Level – Contains non-compliant UL rated assembly for 2-hour enclosure, typical of 3 doors at basement level. West entrance door into shaftway is a single wood door with wood frame. South entrance door into shaftway is a double wood door with wood frame.

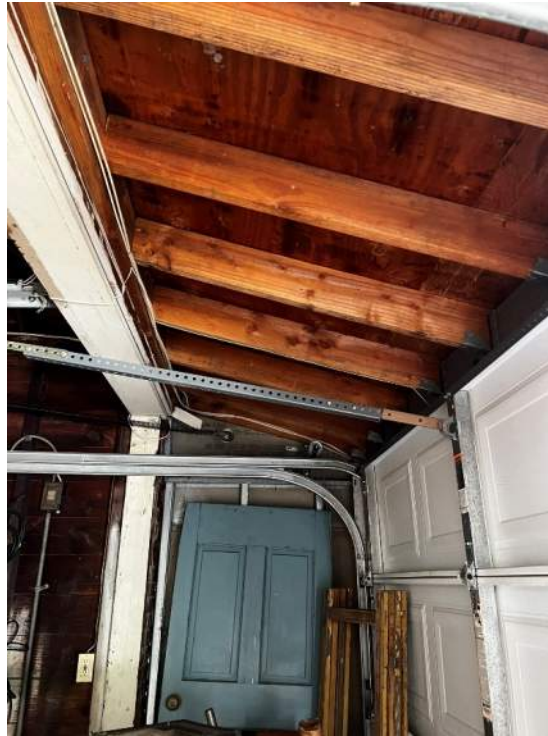
PHOTO 1: IMG_1036 View from Interior of East Addition, age of addition unknown.

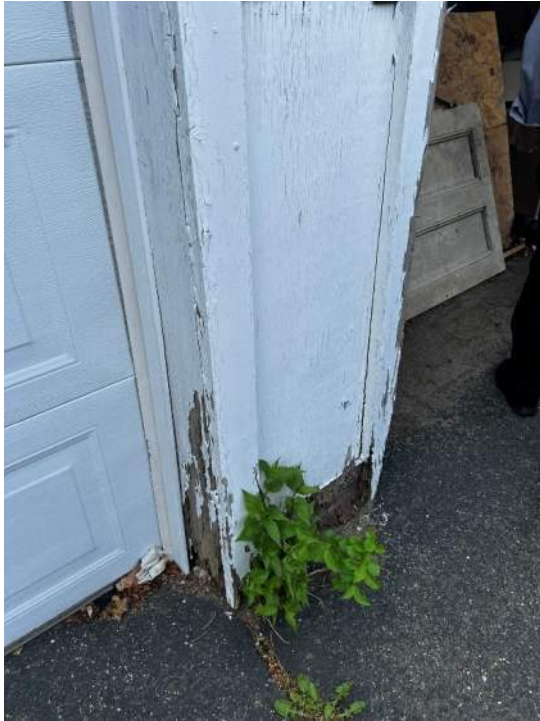
PHOTO 4: IMG_1012 Addition – Exterior wall finish deterioration

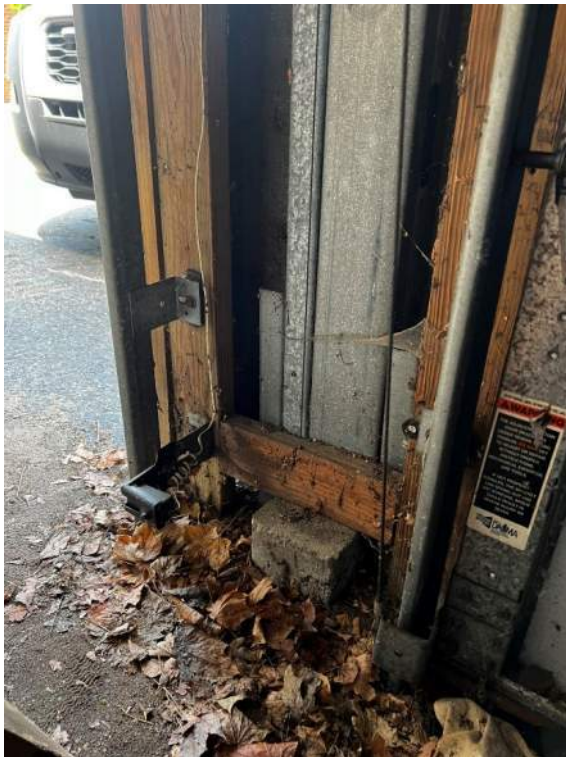
PHOTO 4: IMG_1041 Addition – Metal stud does not rest on built foundation.

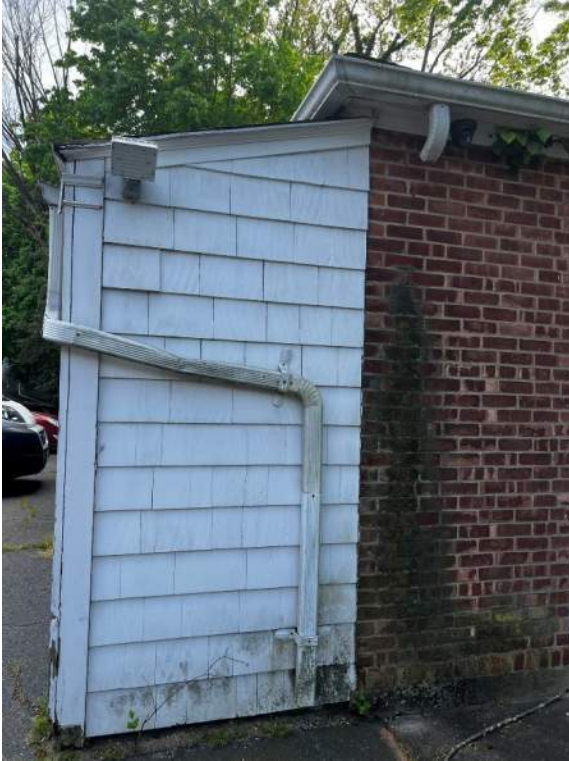
PHOTO 5: IMG_1019 – North Façade : Missing downspout, overgrowth of mold and mildew on façade.

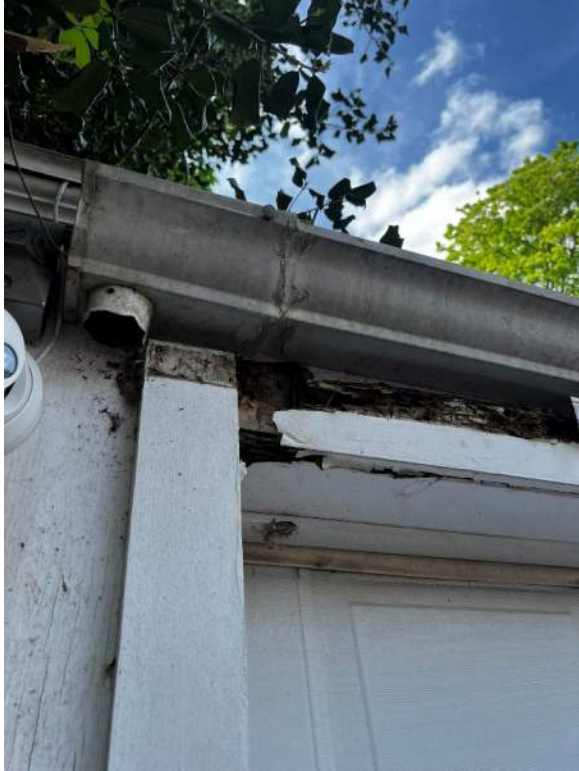
PHOTO 9: IMG_1067 – North Façade. Deteriorated overhead door trim and header. Missing downspouts. Deteriorated seams at gutter.

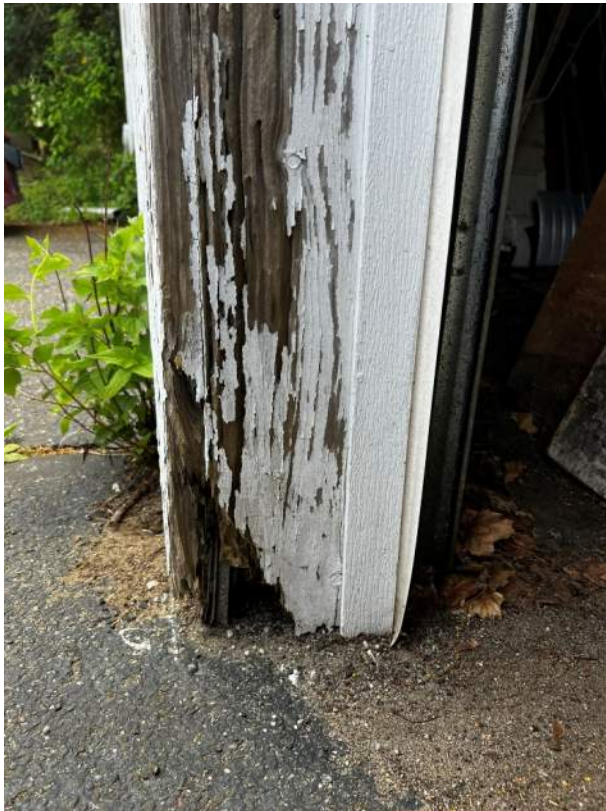
PHOTO 10: IMG_1067 – North Façade. Deteriorated overhead door jambs.

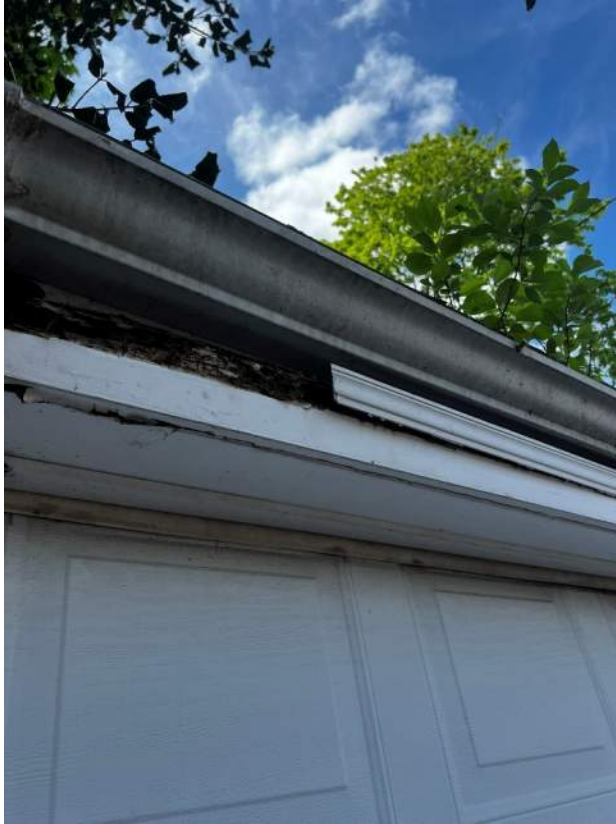
PHOTO 11: IMG_1077 – North Façade. Missing trim work, exposed and deteriorated wood structure.

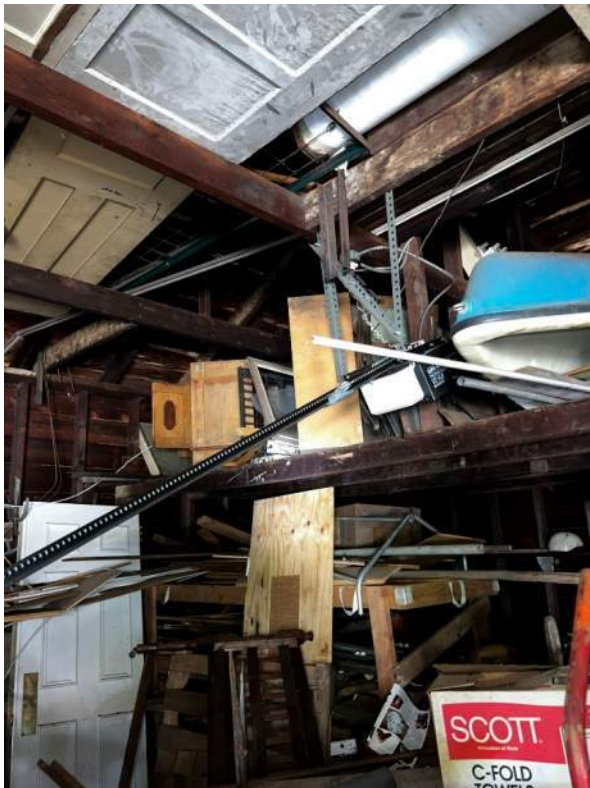
PHOTO 12: IMG_1049 – South Garage door opener / track is broken, requires replacement.

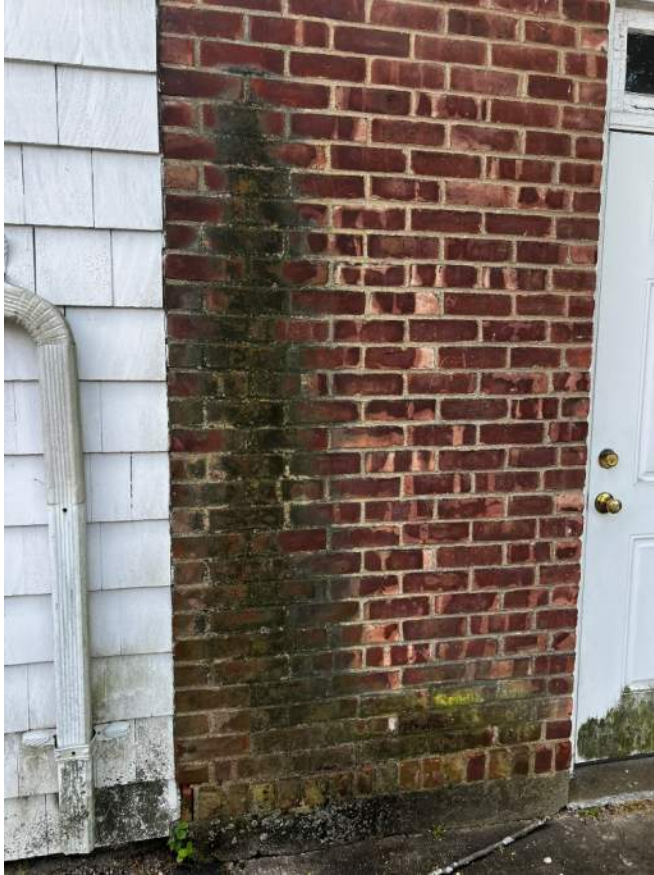
PHOTO 13: IMG_1017 – Entrance door elevation is not ADA compliant. Door hardware is not ADA compliant.

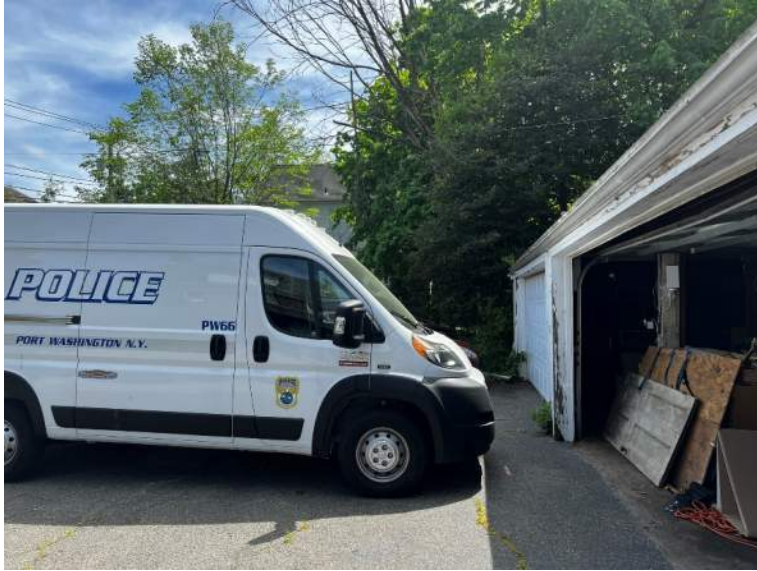
PHOTO 17: IMG_1022 – Height is inadequate for the entire PWP police fleet.

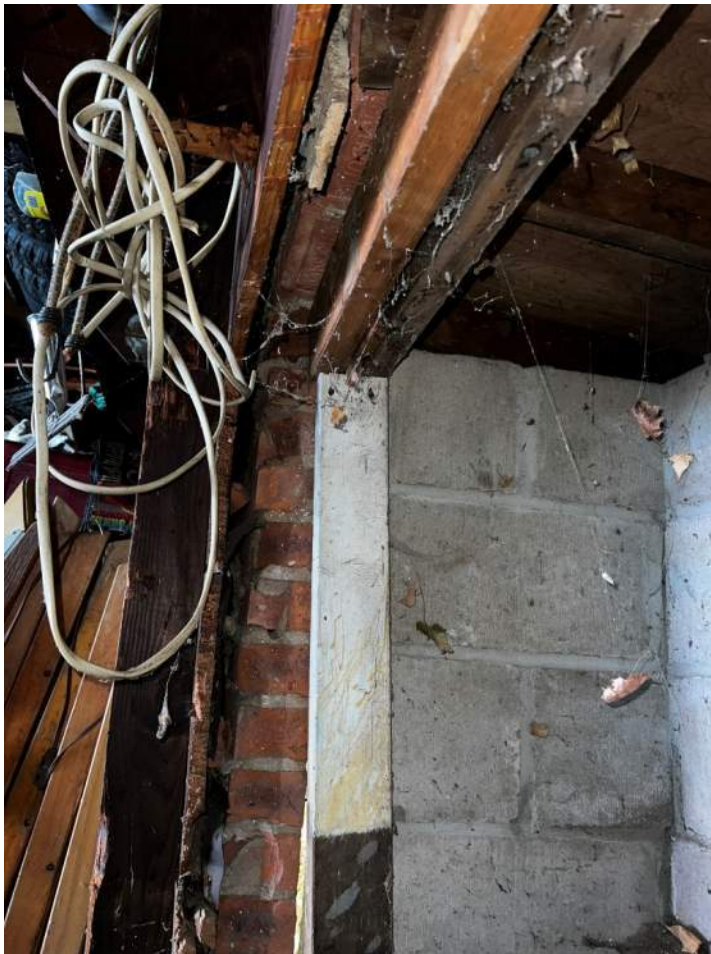
PHOTO 18: IMG_1029 – Brick is not properly supported from below at opening. Horizontal wood member supports the framing of the roof over the CMU bump-out.
