State Environmental Quality Review
NEGATIVE DECLARATION
Notice of Determination of Non-Significance

The Port Washington Police District (District), as lead agency, is hereby issuing this Negative Declaration for the project known as Port Washington Police District New Police Headquarters (Proposed Action). The Proposed Action is an Unlisted action as that term is defined in SEQRA.

Proposed Action:	Port Washington Police District New Police Headquarters
Lead Agency:	Port Washington Police District
Proposed Action Site:	128 Main Street, 10 Mackey Avenue & 97, 99, 101, 103 & 105 Webster Avenue, Port Washington, NY, 11050 NCTM: Section 5 Block 38 Lots 8, 408-412 & 416-418
SEQRA Status:	Unlisted, Coordinated Review

Building Name:	Austin F. Knowles Funeral Home (Main Building)
Building Number:	128 Main Street, Port Washington, NY
Date Surveyed:	May 3, 2024 – Exterior, Basement & First Floor May 8, 2024 – Second Floor and Attic

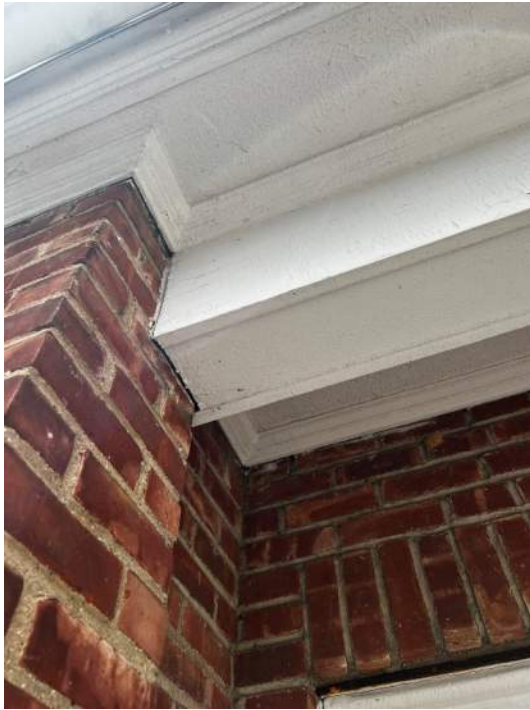
PHOTO 5: IMG_1093 – South Façade – age of wood & visible shrinkage

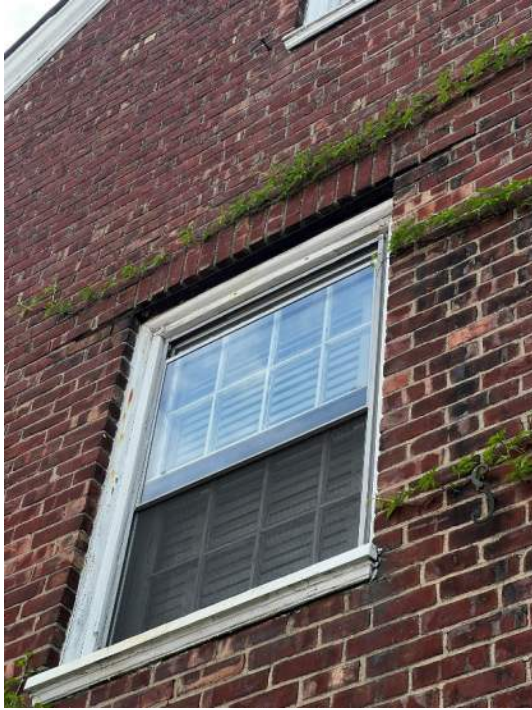
The east façade facing Mackey Avenue has significant wood deterioration at the exterior door trim and is missing entire pieces of trim (photo 12). The exterior wall contains significant bulging in brick, visually observed for three (3) second floor windows and two (2) attic windows (photos 10 & 11).

PHOTO 11: IMG_1077 – East Façade – Close up of brick bulging above window headers. Visible shutter brackets with missing shutters.

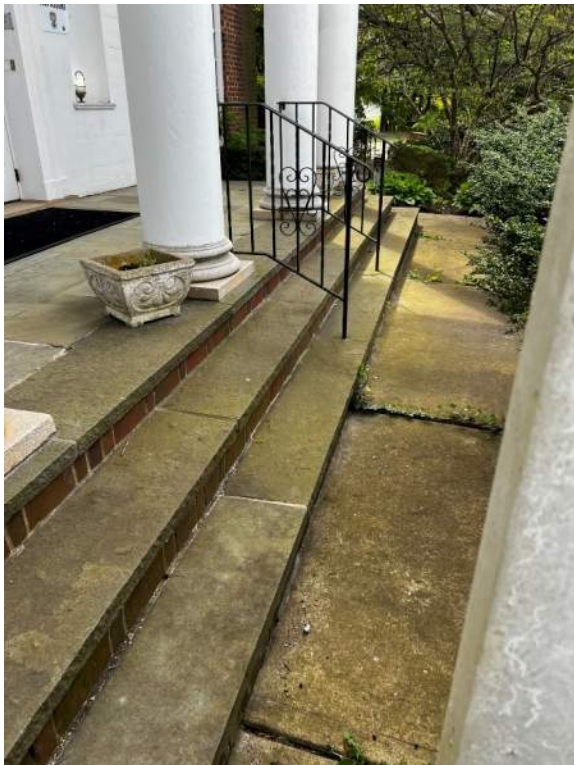
The building egress do not meet the requirements of the Americans with Disabilities Act (ADA). There are four (4) existing points of entry to the structure. The front entry on the north façade is non-ADA compliant. Public entrances are required to have stairs with compliant handrails and a ramp. The ADA requires ramps be installed along accessible routes in public areas for elevation changes greater than ½" (photo 14).

PHOTO 14: IMG_1156 – North Façade – Main entrance and acting egress door exits is not ADA accessible. Non-compliant handrails, riser and tread heights, and does not contain a ramp.

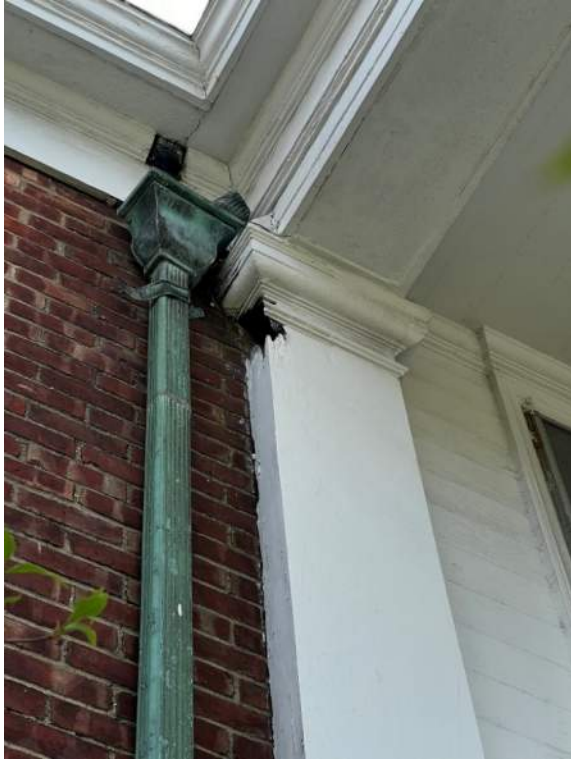
The painted wood façade elements on the North Façade (front) are chipping, exposing the wood to the elements, and the wood has begun to weather (photo 16). The exterior wall is missing a downspout causing water to drain directly onto the foundation wall (photo 15). Additionally, the internal downspout to collector

box is dislodged, allowing water to drain directly onto the brick masonry and wooden elements of the funeral home causing significant deterioration (photo 17).

PHOTO 17: IMG_1151 – North Façade (North East of front entrance) - Internal downspout to collector box is dislodged, allowing water to drain onto brick masonry and wooden elements.

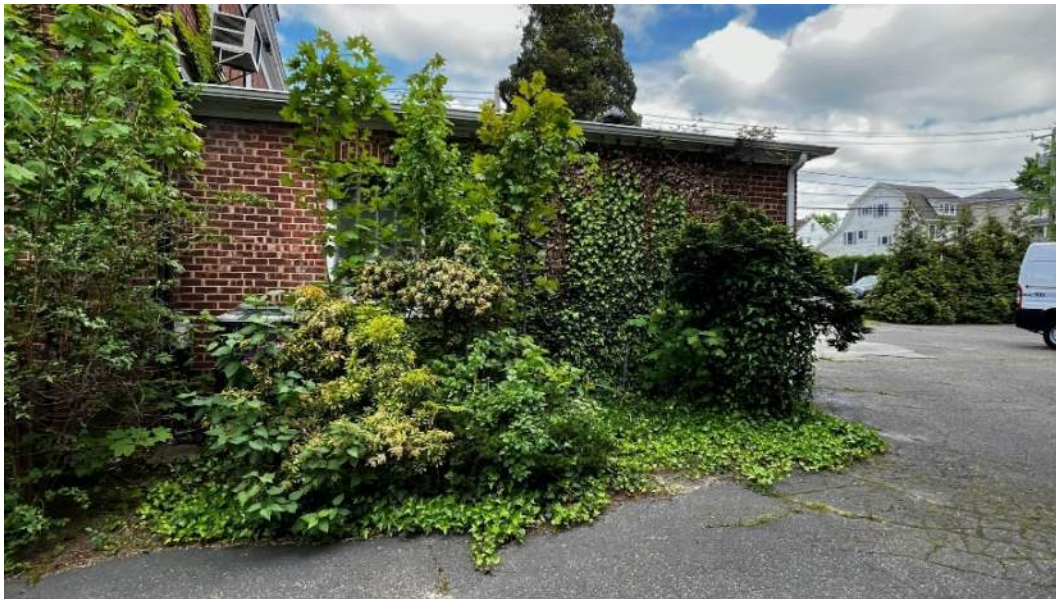
The exterior walls of the funeral home consist of wood stud construction with brick veneer. The exterior façade has significant mold, mildew, and ivy growth indicating trapped moisture (photos 8, 10, 19, & 20). The gutters are overgrown with ivy and clogged; the clogged gutters and mold and mildew growth has led to retained moisture, dislodging exterior brick.

PHOTO 20: IMG_1320 – West Facade–Significant ivy growth which should be removed.

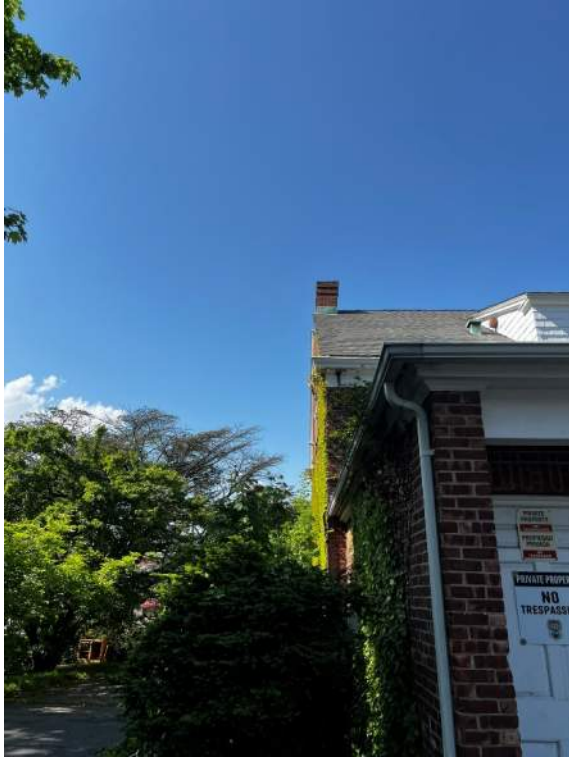
The chimney on the west façade is leaning inwards towards the building and is at risk of failure (photo 21). Additionally, there is visible efflorescence at the inside brick corner (photo 24) with significant water damage at the interior side of the inside corner.

The condition of the west and east chimneys also indicates water damage and support issues. The brick masonry by the west chimney is not supported properly from below, corbelled off the exterior wall (photo 77). The west chimney is also exhibiting significant leaning from the exterior view (photo 21). The east chimney structure is corbelled off with significant cantilevered bricks with visible light coming through between the roof framing and chimney indicating that the roof is not fully enclosed for protection from the

PHOTO 21: IMG_1719 – West Facade–Chimney leaning inwards towards building.

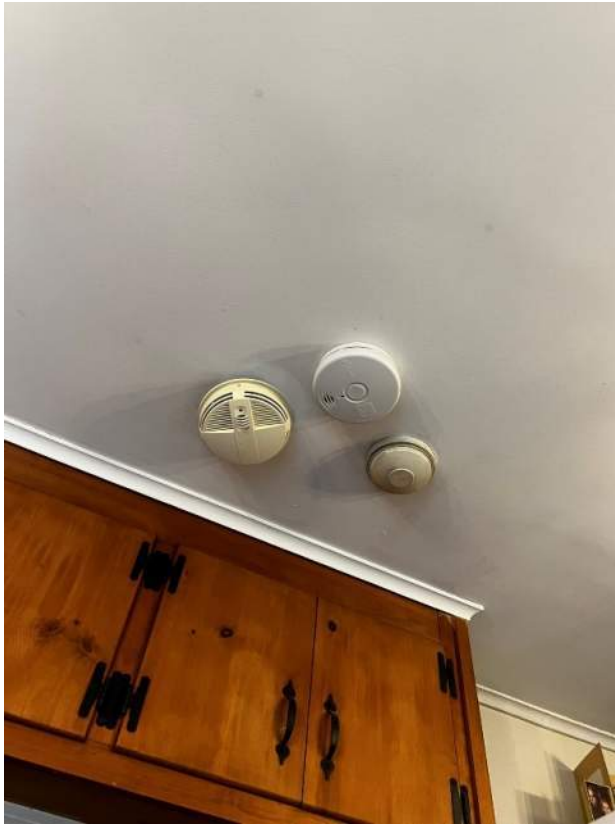
The first floor of the funeral home includes the west chapel, sitting room, prep room, office/anteroom to the prep room, toilet room, and gender-neutral toilet room (see Attachment D). There are some life safety concerns throughout. The floor contains non-functioning pull stations (photo 26) and the multiple fire alarm devices, non-hard wired carbon monoxide detectors, can be assumed to be redundant devices as the system is non-functioning.

Photo 27: IMG_1173 - Interior 1st Floor, Rear Office – Multiple fire alarm devices, non-hard wired carbon monoxide detector. Assumed redundant devices due to non-functioning system.

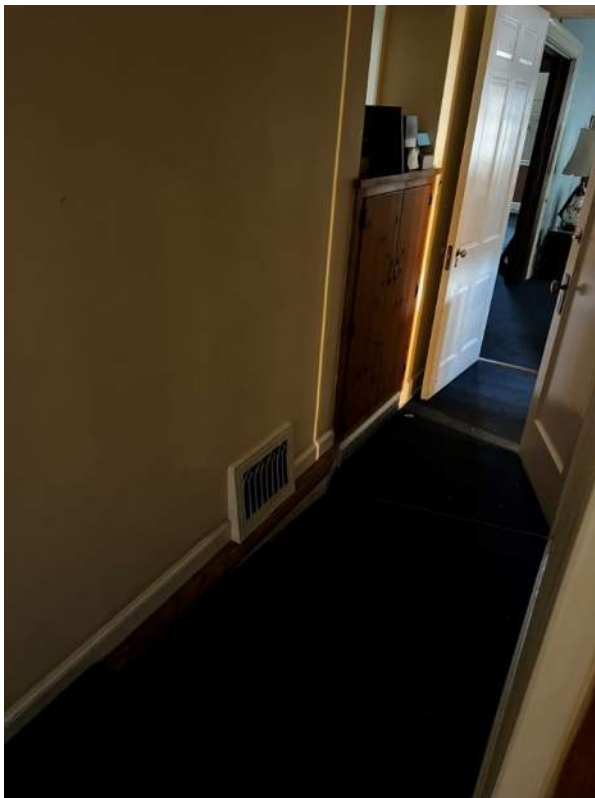
Photo 36: IMG_1208 - Interior 1st Floor, Hallway from Office to North East room – Floor surface contains a non-compliant ramp – non-compliant slope and no handrails.

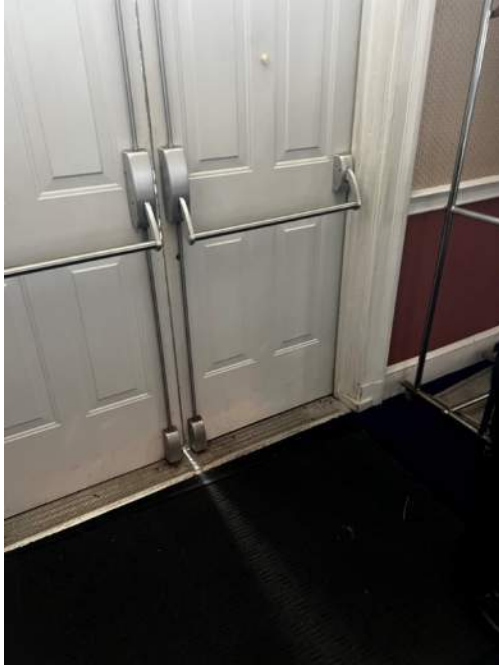
Photo 37: IMG_1219 - Interior 1st Floor, Main Entrance Doors – Entrance is not protected with an enclosed vestibule as required by 2020 ECCNYS C402.5.7. Door does not contain weatherstripping for compliance with 2020 ECCNYS C402.5 – Air Leakage – Thermal Envelope.

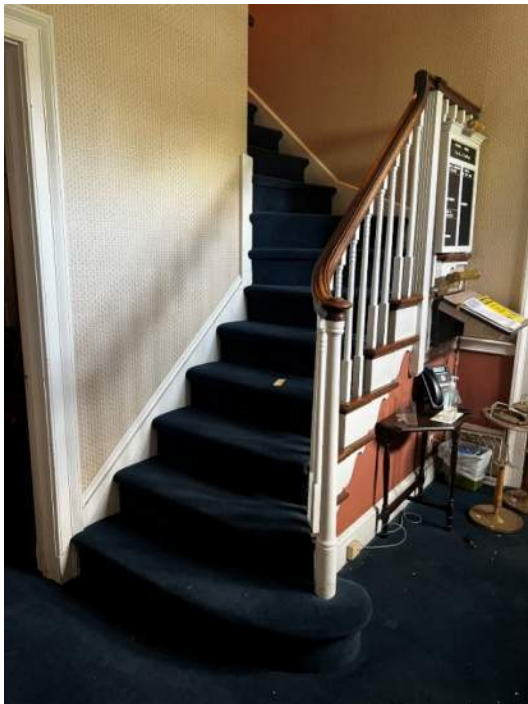
Photo 38: IMG_1220 - Interior 1st Floor, Main Stair is non-compliant with 2020 BCNYS Chapter 10 Means of Egress Sizing : 2'-10 ½" clear width, 2'-7" High handrail height, 3'-3 ½" guardrail height and winder stair treads. Handrails are not continuous without interruption by newel posts and do not extend past the top and bottom risers (2020 BCNYS 1012.4 & 1012.5). Handrails are not present on each side (2020 BCNYS 1009.10).

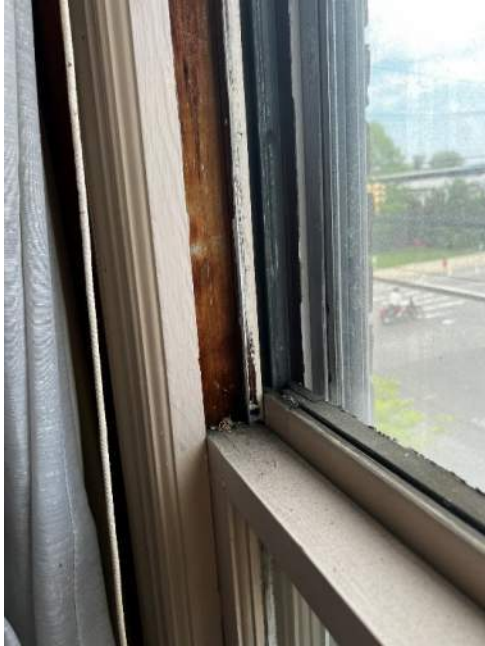
Photo 43: IMG_1468 - Interior 2nd Floor, East Funeral Chapel (& throughout) – Various windows are non-functional throughout entire building. The windows throughout utilize a rope and pulley string for operation; various windows contain ropes that have dry-rotted and subsequently, broken. Many windows with rope and pulley systems intact are non-functional due to multiple layers of paint and lack of use leaving a handful of windows operable for ventilation purposes.

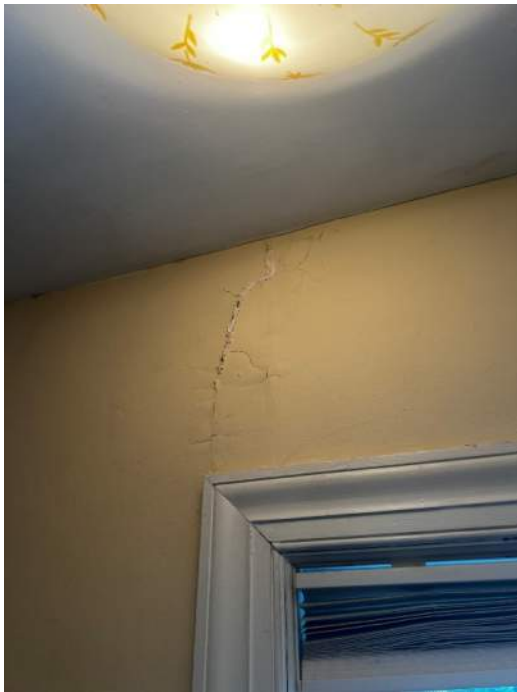
The window on the east side egress stair is operable, however, the interior jambs of window are exhibiting deterioration of the paint finish and wood below (photo 47). There is also moderate cracking in the plaster finish, with its origins from the window corners and requires refinishing (photo 44). The plaster wall finish is chipping and peeling from evident water infiltration and moisture into wall finish (photo 45). In the area above the stairs, the plaster wall finish is beginning to crack, bulge and bow and requires refinishing (photo 46).

Photo 44: IMG_1427 - East side egress stair, top landing – Moderate cracking in plaster finish with origins from window corners. Requires refinishing (photo 44).

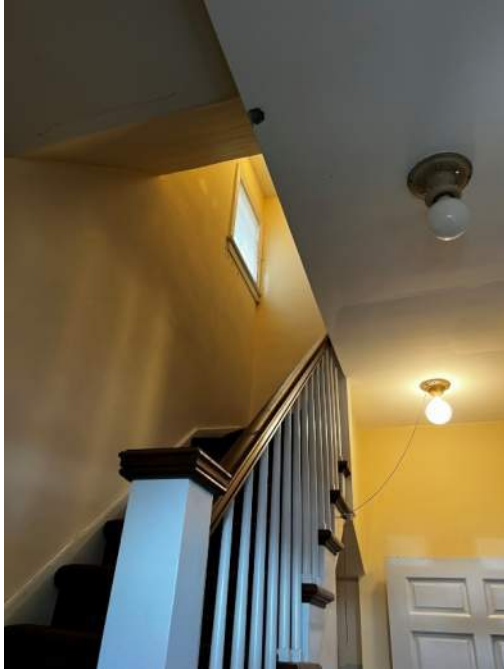
Photo 49: IMG_1239 - East side egress stair. Egress stair is non-compliant with 2020 BCNYS Chapter 10 Means of Egress Sizing: 2'-10" clear width, 2'-5" High handrail height and winder stair treads. Handrails are not continuous without interruption by newel posts and do not extend past the top and bottom risers (2020 BCNYS 1012.4 & 1012.5). Handrails are not present on each side (2020 BCNYS 1009.10).

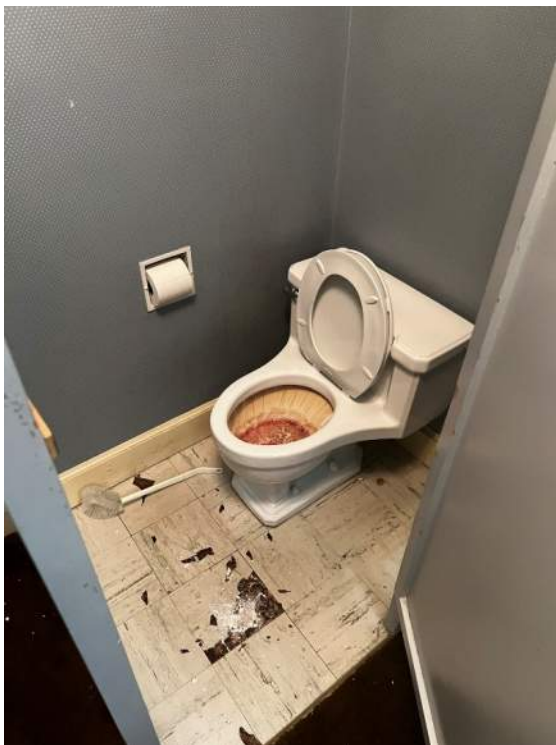
Photo 50: IMG_1440 – Second Floor Gender-Neutral Toilet Room - Toilet room is not ADA compliant or sized adequately for conversion for ADA compliance. Toilet room contains asbestos containing materials (ACM) which require to be abated.

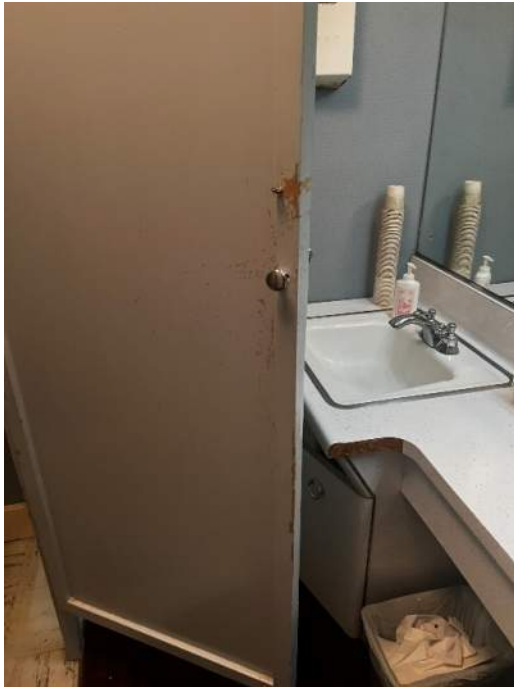
Photo 51: IMG_1441 – Second Floor Gender-Neutral Toilet Room - Toilet room is not ADA compliant or sized adequately for conversion for ADA compliance. Toilet room contains asbestos containing materials (ACM) which require to be abated.

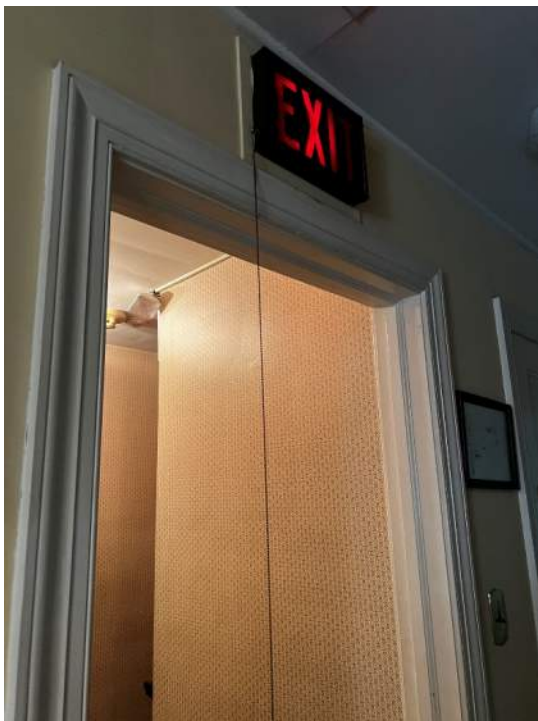
Photo 52: IMG_1444 – Second Floor Corridor – Emergency exit sign is present, but not continuously illuminated. Pull string cord activates illumination. Exit sign is not directional.

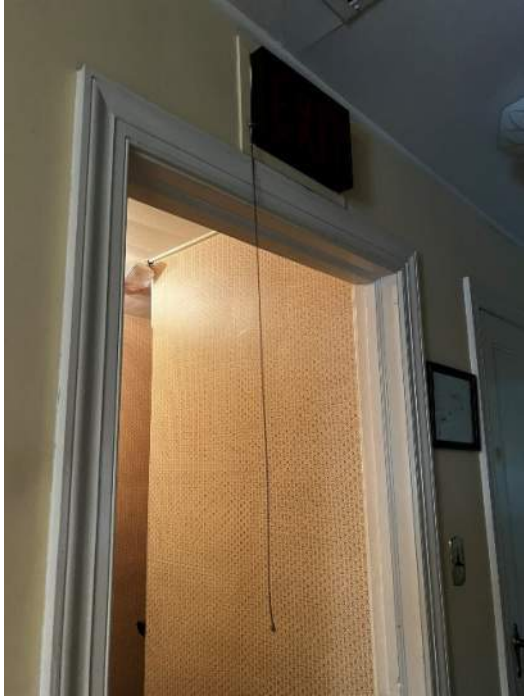
Photo 53: IMG_1445 – Second Floor Corridor – Emergency exit sign is present, but not continuously illuminated. Pull string cord activates illumination. Exit sign is not directional.

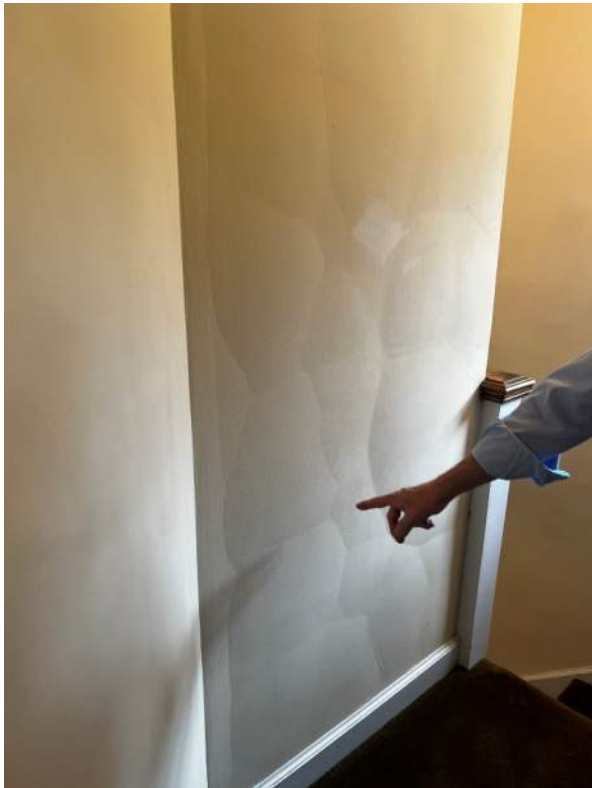
Photo 54: IMG_1446 – Second Floor Corridor – Plaster wall finish is uneven, bowing and bulging.

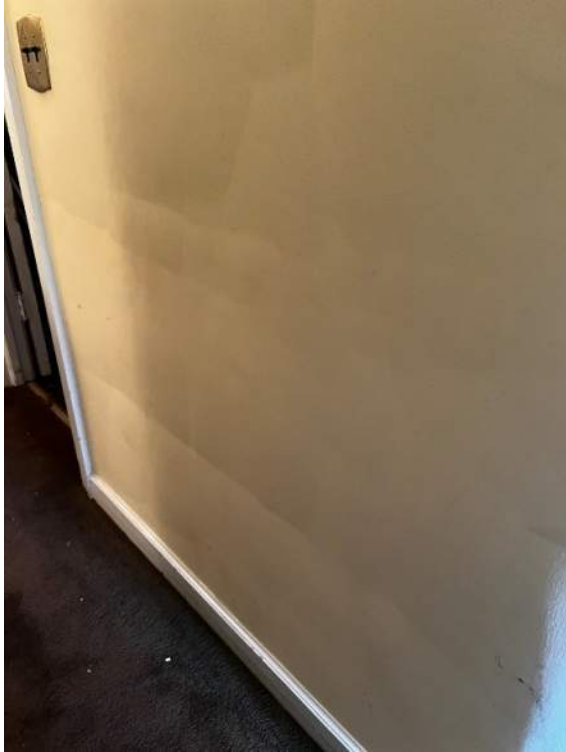
Photo 55: IMG_1449 – Second Floor Corridor – Plaster wall finish is uneven, bowing and bulging.

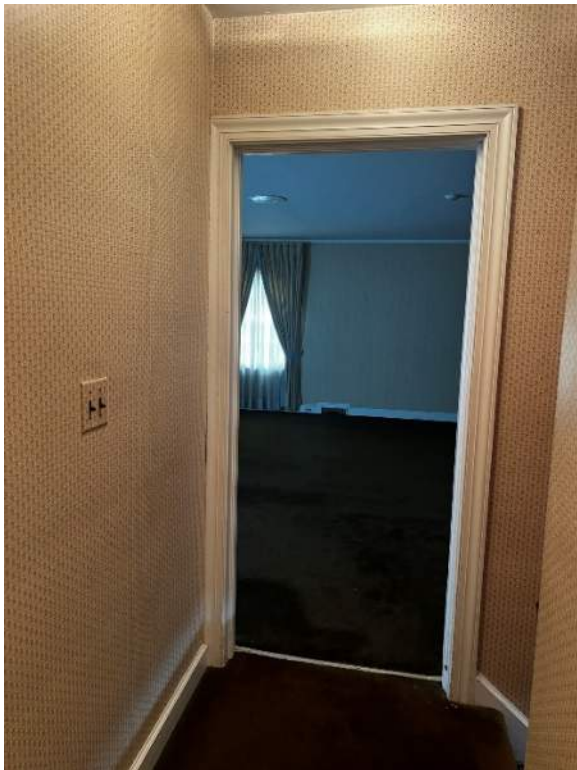
Photo 56: IMG_1459 – Second Floor Landing at Top of Main Stair – Non handicap accessible clearances at doorways and stair landings. Non-compliant handrail extensions.

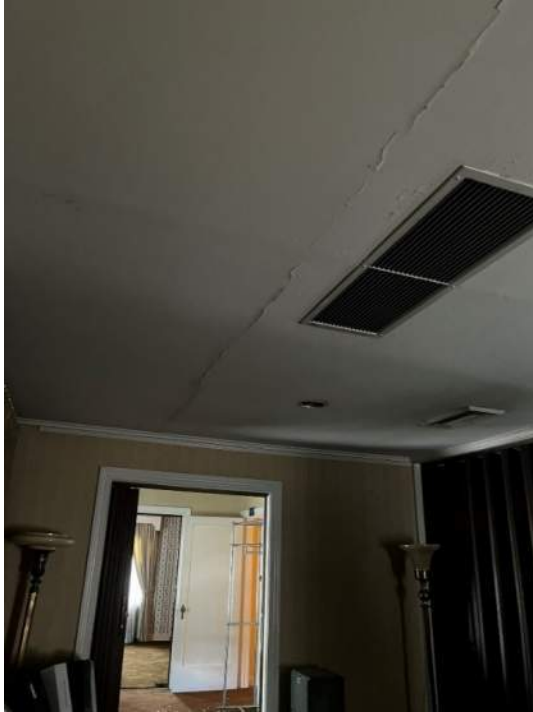
The Northwest Chapel ceiling exhibits cracking due to the deflection of the wood framing. These cracks in the ceiling run the full length and width of room (photos 63 & 64).

Photo 63: IMG_1489 – Second Floor Northwest Chapel – Ceiling exhibits cracking due to deflection of wood framing. Cracks in ceiling run full length and width of room. Building does not contain emergency egress lights; main source of illumination is portable lamps.

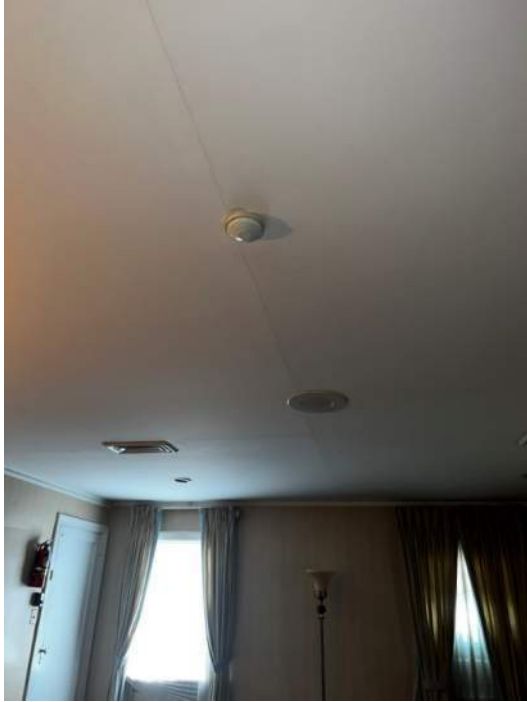
The Southwest Chapel ceiling exhibits cracking due to the deflection of the wood framing. These cracks in the ceiling run the full length and width of the room (photo 65). The wall finish exhibits bowing at the interior walls (photo 67).

Photo 65: IMG_1497 – Second Floor Southwest Chapel – Ceiling exhibits cracking due to deflection of wood framing. Cracks in ceiling run full length and width of room. Building does not contain emergency egress lights; main source of illumination is portable lamps.

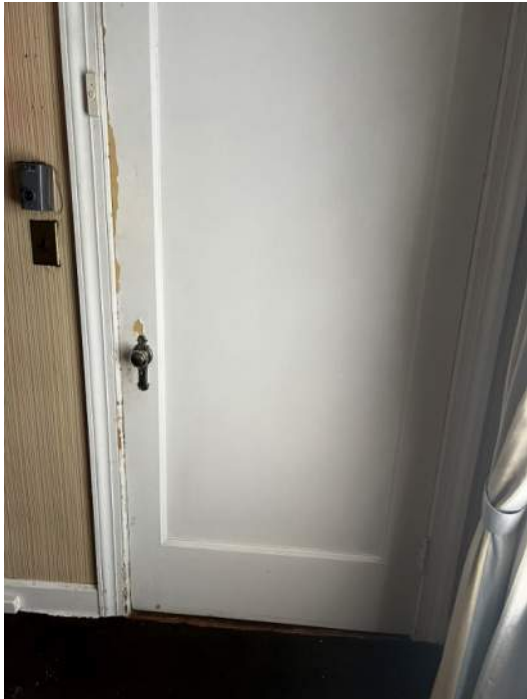
Photo 66: IMG_1502 – Second Floor Southwest Chapel – Elevator shaft enclosure (wall construction and door) are not rated. Per 2020 BCNYS shaft enclosures shall have a fire-resistance rating of not less than 2-hours where connecting four or more stories. This shaft enclosure connects 4-stories (basement, first floor, second floor and attic).

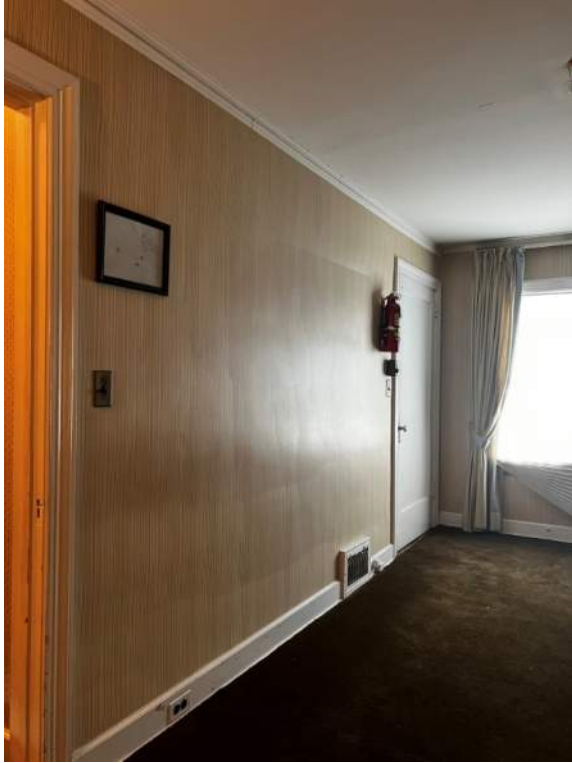
Photo 67: IMG_1507 – Second Floor Southwest Chapel – Wall finish exhibits bowing at interior walls. Fire extinguisher is not mounted in compliance with NFPA 10. Light switches and receptacles are not mounted in compliance with ADA.

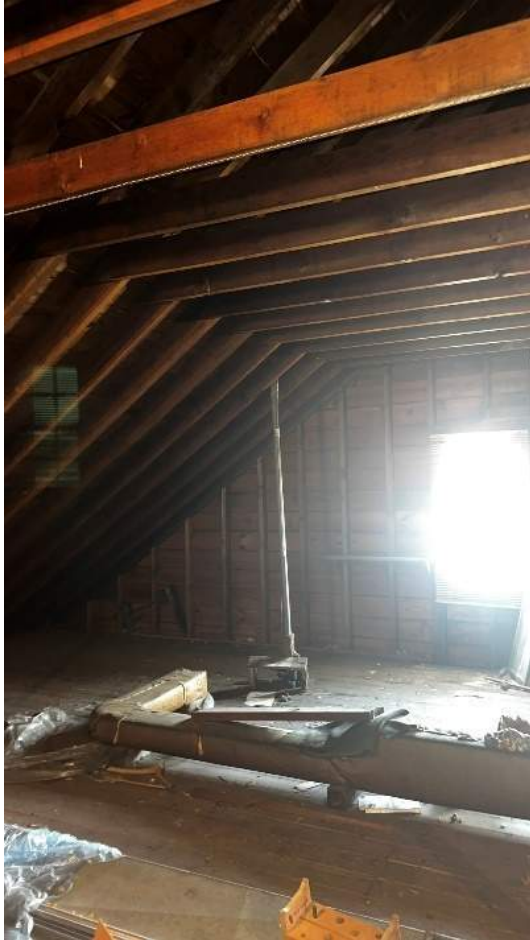
Photo 71: IMG_1541 – Attic does not contain a fire sprinkler system.

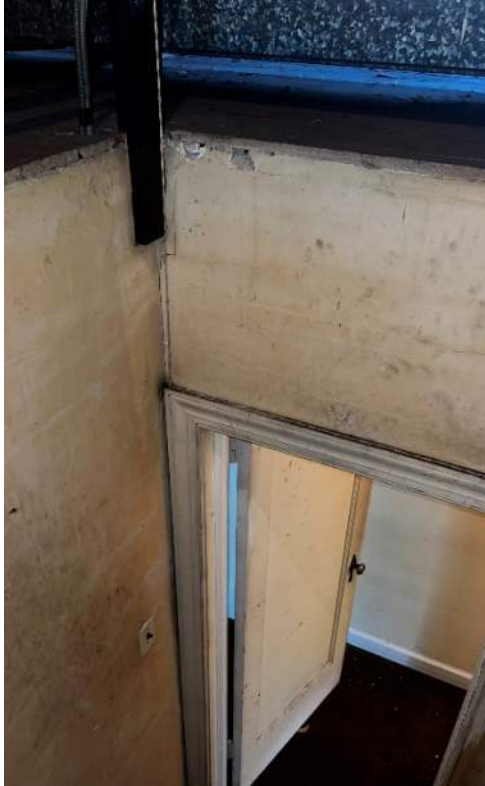
The attic entrance features plaster walls on wood-stud wall construction. The plaster is beginning to crack and degrade, exposing the wall cavities (photo 73).

Photo 73: IMG_1535 - Plaster walls on wood-stud wall construction up to attic level. Plaster beginning to crack and degrade, exposing wall cavities.

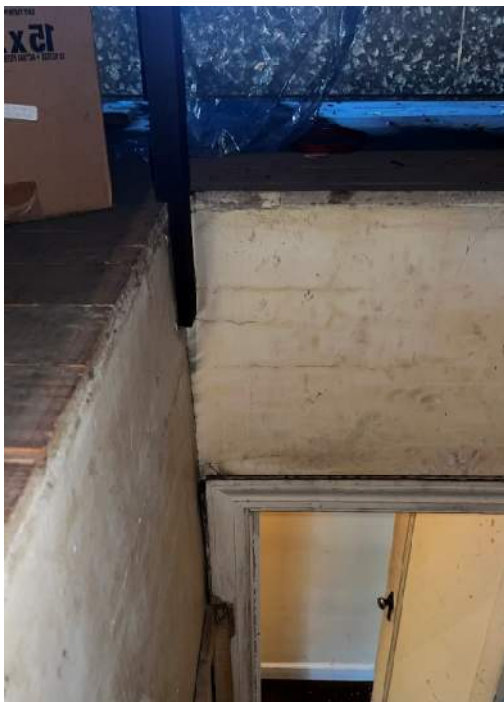
Photo 74: IMG_1536 - Stairs do not contain code compliant balustrades, guards or adequate opening limitations that would prevent the passage of a 4" sphere.

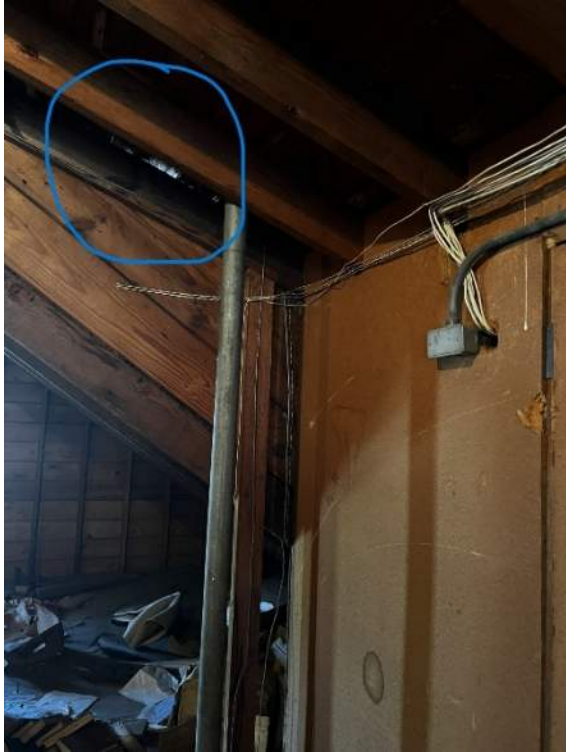
There is significant evidence of water damage in the attic. In multiple spots, light is visible from under eaves and roof framing, indicating that the roof is not fully enclosed for protection from the elements (photos 75 & 76). There is visible rot and moisture infiltration at the roof deck surrounding the plumbing vent stack, indicating inadequate flashing (photo 79). Similarly, there is visible rot and moisture infiltration on the roof deck in the Northeast portion of the attic (photo 81) and the roof deck and gable end wall (photo 86). Additionally, there are areas of the roof deck which have been replaced. A review of the asphalt shingle roof is recommended (photo 80).

Photo 75: IMG_1579 – Light is visible from below roof framing to exterior.

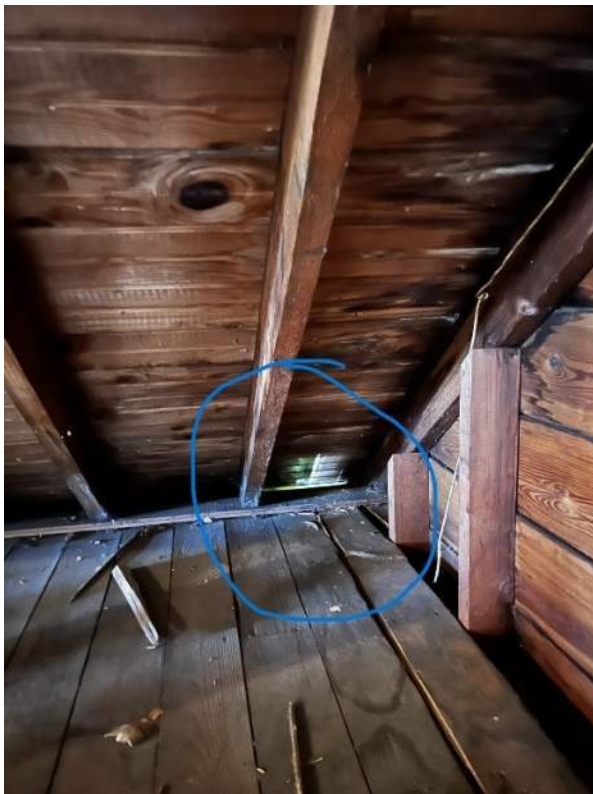
Photo 76: IMG_1562 – Light is visible from below roof eaves.

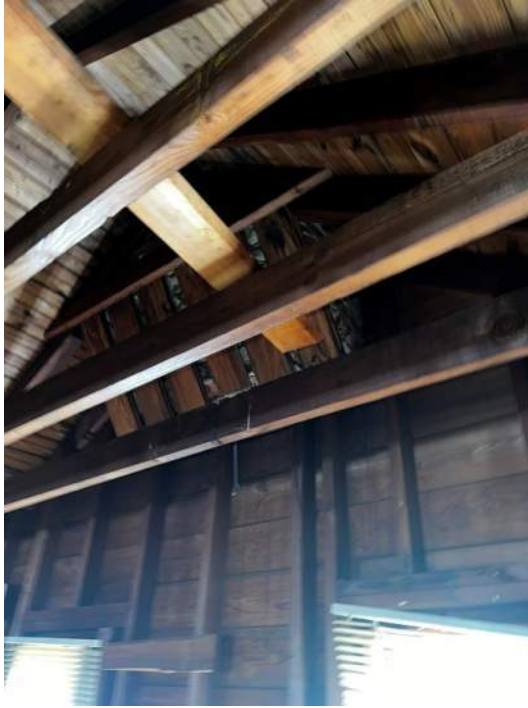
Photo 77: IMG_1560 – West Chimney is not properly supported, corbelled off exterior wall. West chimney is exhibiting significant leaning from exterior view (reference photo 21).

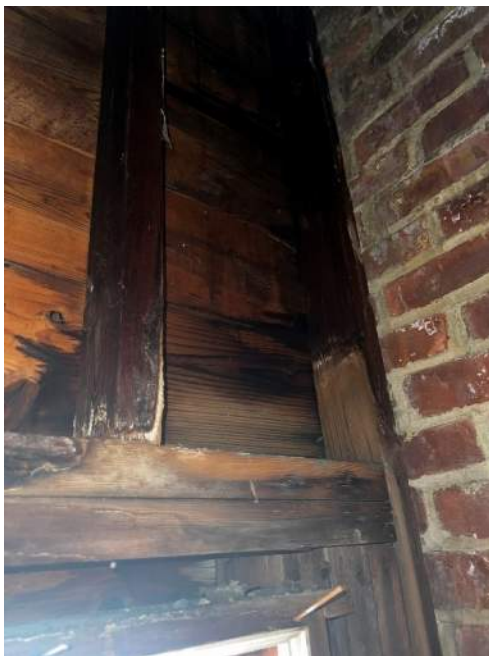
The wood framing above the windows on the east side also exhibit significant water damage. The visible water damage aligns with the brick bulging (photo 10) on the exterior which indicates significant water damage is likely to be found at all window framings on the east wall (photo 82).

Photo 82: IMG_1557 – Wood framing above windows on East side attic exhibit significant water damage. The visible water damage aligns with the brick bulging (photo 10) from exterior which indicates significant water damage is likely to be found at all window framing on East wall.

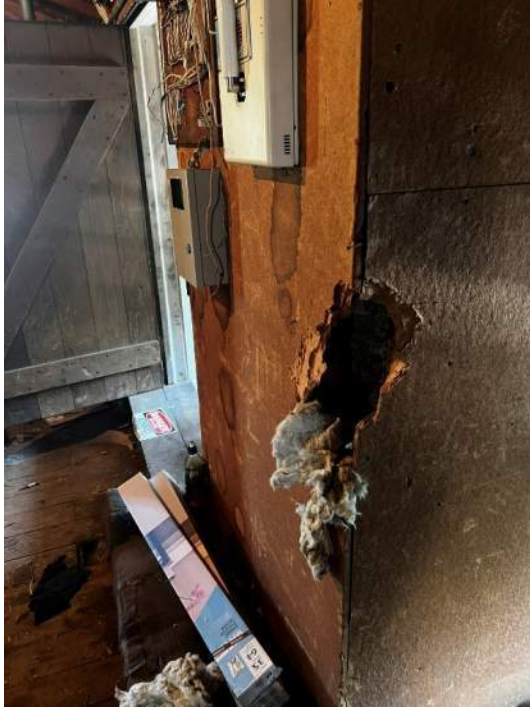
Photo 83: IMG_1622 – Elevator shaft way through attic is constructed of non-rated particle board. Per 2020 BCNYS shaft enclosures shall have a fire-resistance rating of not less than 2-hours where connecting four or more stories. This shaft enclosure connects 4-stories (basement, first floor, second floor and attic) (photo 82).

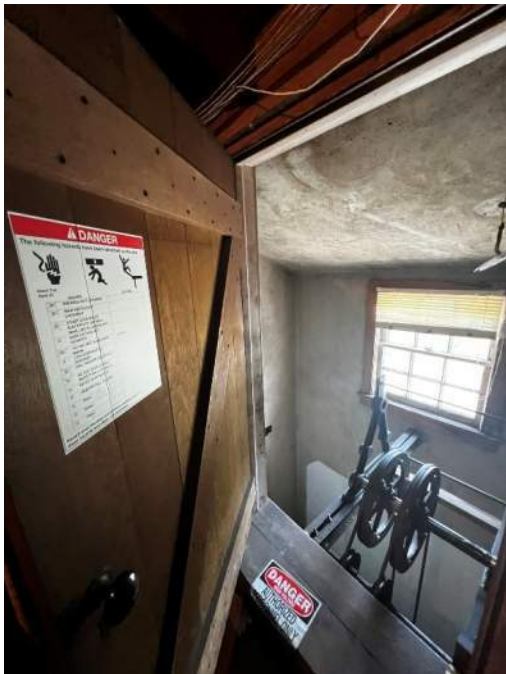
Photo 84: IMG_1584 – Elevator access door opens to elevator shaft way with no fall protection. Per OSHA 1917.116, elevator landing openings shall be provided with doors, gates or equivalent protection which shall be in place when the elevator is not at that landing, to prevent employees from falling into the shaft.

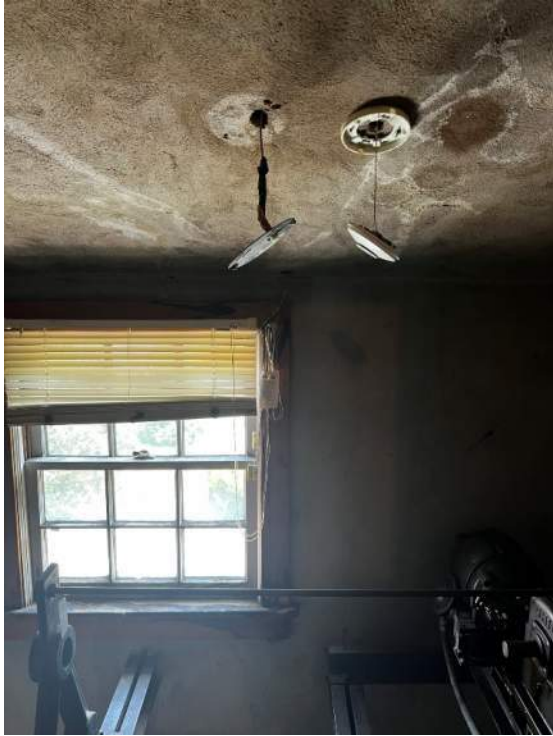
Photo 85: IMG_1588 – Elevator shaftway contains a window. Per 2020 BCNYS shaft enclosures shall have a fire-resistance rating of not less than 2-hours. Window opening requires to have the same fire-rating as the wall assembly. Elevator shaft way contains non-functioning fire alarm devices.

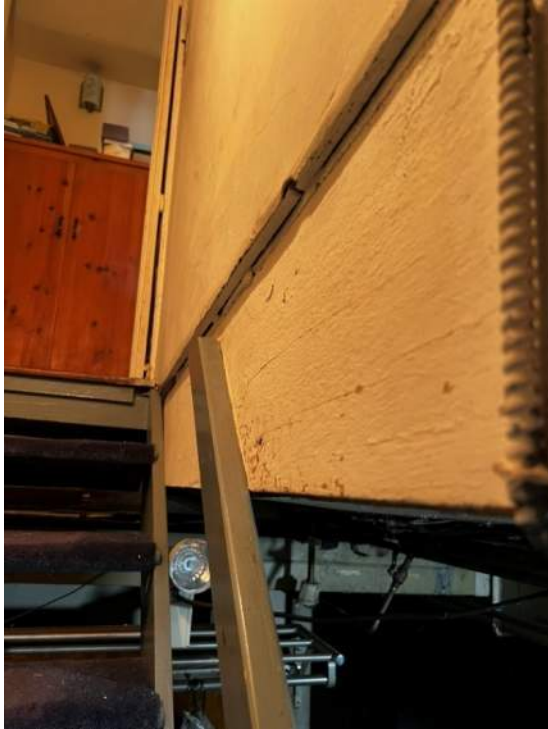
Photo 89: IMG_1243– Basement egress stairs non-compliant with 2020 BCNYS and are not ADA compliant. Stairs feature non-complaint handrails, open stair treads, and are not enclosed with an exit at an exit discharge or to a public way.

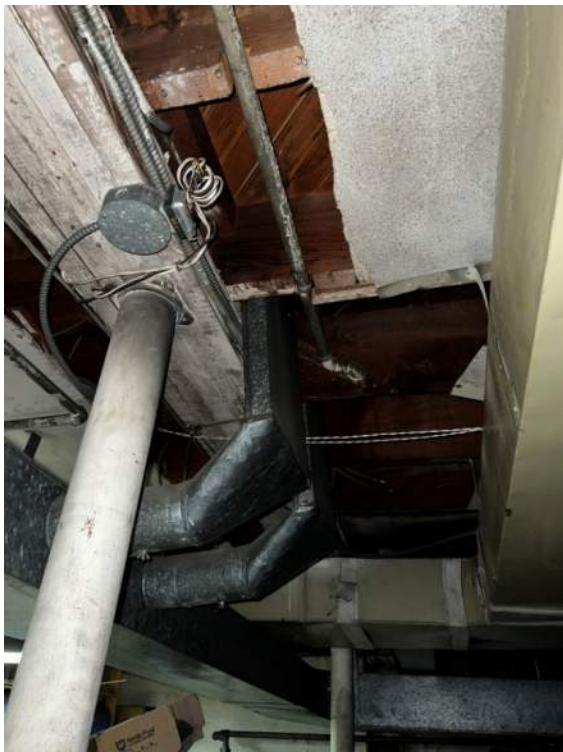
Photo 90: IMG_1248– Floor joists feature notches and holes. If configuration of interior walls, stairwells, finishes are altered and changing structural dead loads, and if interior live loads are altered based on occupancy reclassification, joists shall require to be evaluated by a structural engineer.

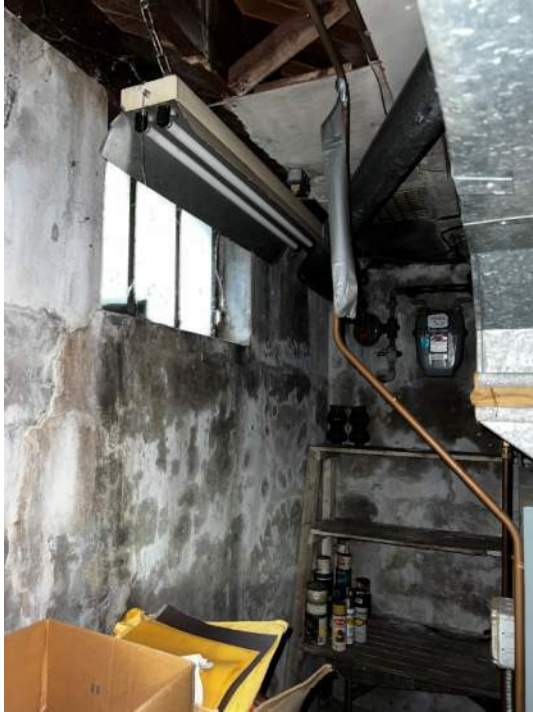
Photo 91: IMG_1251– Significant moisture and water staining is present on Northeast foundation walls.

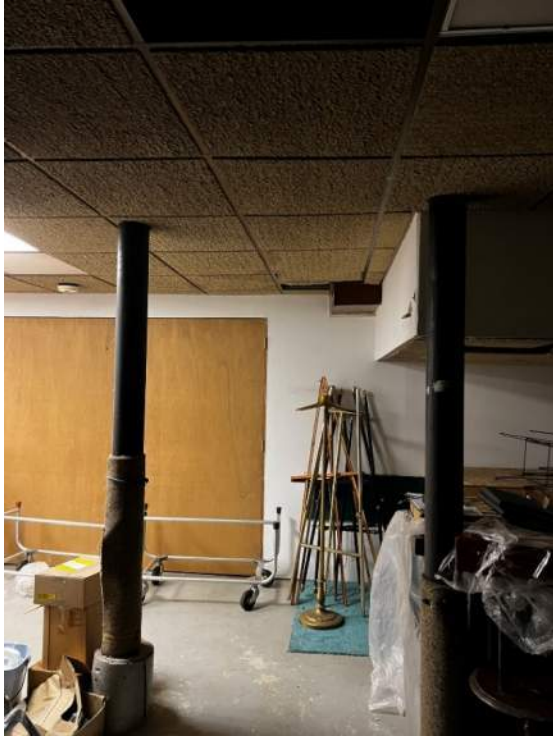
Photo 95: IMG_1672– Elevator shaft at Basement Level – Contains non-compliant UL rated assembly for 2-hour enclosure, typical of 3 doors at basement level. West entrance door into shaft way is a single wood door with wood frame. South entrance door into shaft way is a double wood door with wood frame.

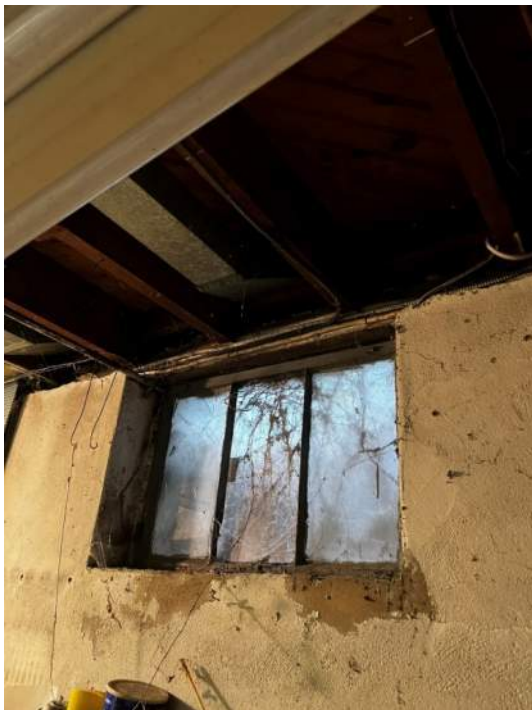
Photo 96: IMG_1302– Visible moisture infiltration at sub-grade windows. Foundation wall paint finish exhibits cracking and chipping. Basement Window wells contain overgrown shrubs and leaves, recommended cleaning of window wells to assess conditions of window frames from exterior.

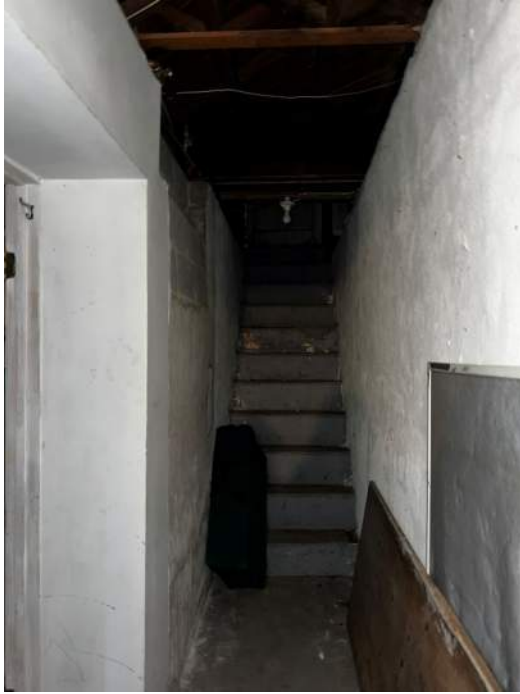
Photo 97: IMG_1276– Basement stairs to Exterior – Non-compliant riser and tread heights per 2020 BCNYS 1011.5.2. Existing poured concrete stairs have a 9.5” riser height and a 9.25” tread depth. Stairs do not contain handrails. Landing at top of stairs is not compliant with 2020 BCNYS 1012.6.3 the landing length shall be 60 inches minimum. Approach to door is not ADA compliant.

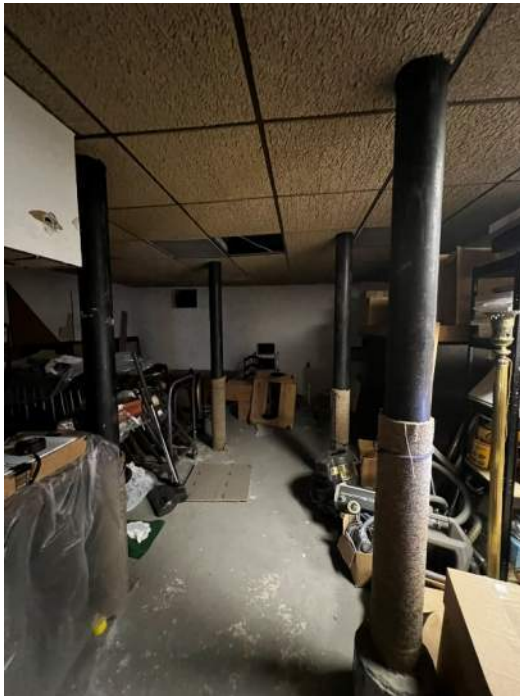
-	South back room (below office) – Contains steel lally columns with non-uniform spacing. Column placement and spacing suggests additional columns were added for reconfiguration of openings on first floor (photo 98).

Photo 98: IMG_1669– Basement – South back room (below office) – Contains steel lally columns with non-uniform spacing. Column placement and spacing suggests additional columns were added for reconfiguration of openings on first floor,

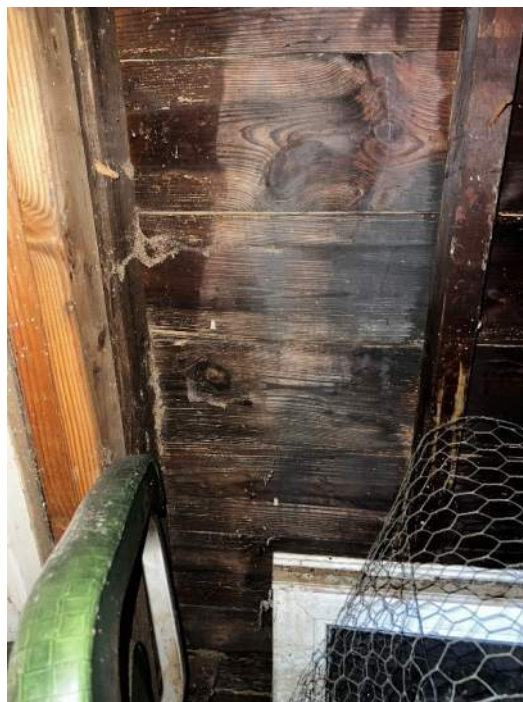
PHOTO 2: IMG_1056 Visible Termite Damage – termite tunnels and droppings

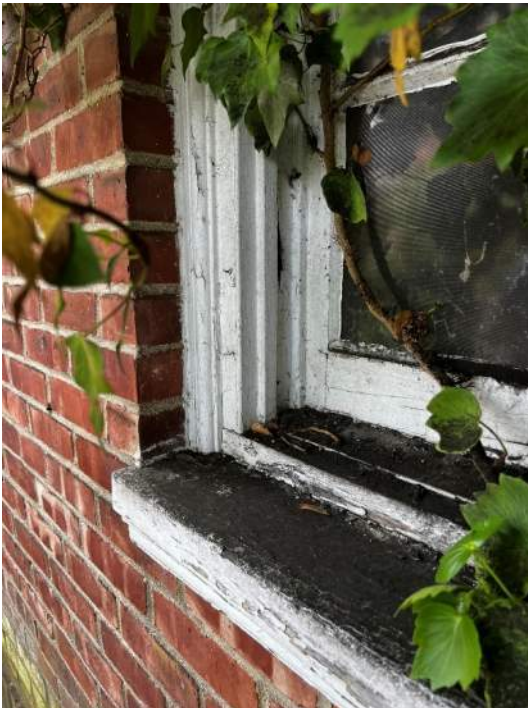
PHOTO 7: IMG_1021 – South Façade

IA	North Side Roof – Significant moss growth on roof shingle.
Façade	G	South Façade (photo 7) Exterior Wall – Brick masonry in good condition.
	IA	Exterior Wall - Minor ivy growth which should be removed.
	G	Foundation (observable only) – concrete.
	IA	Drainage – Downspouts to grade, no underground storm water retention system visible or visible solutions for water percolation of soil.
	IA	West Façade (photo 8) Exterior Wall – Brick and gutters are overgrown with ivy. Overgrowth can lead to retained moisture, dislodging brick and moisture, or attract insects and wildlife.
	CV	Exterior Wall – exposed CMU bump-out with no exterior finish, insulation, or moisture protection system; risks of water and moisture entering building.

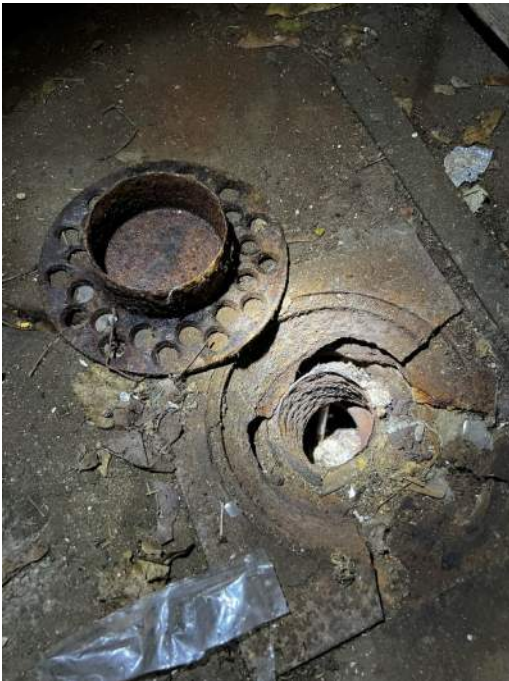
PHOTO 16: IMG_1046 – Clogged floor drains.

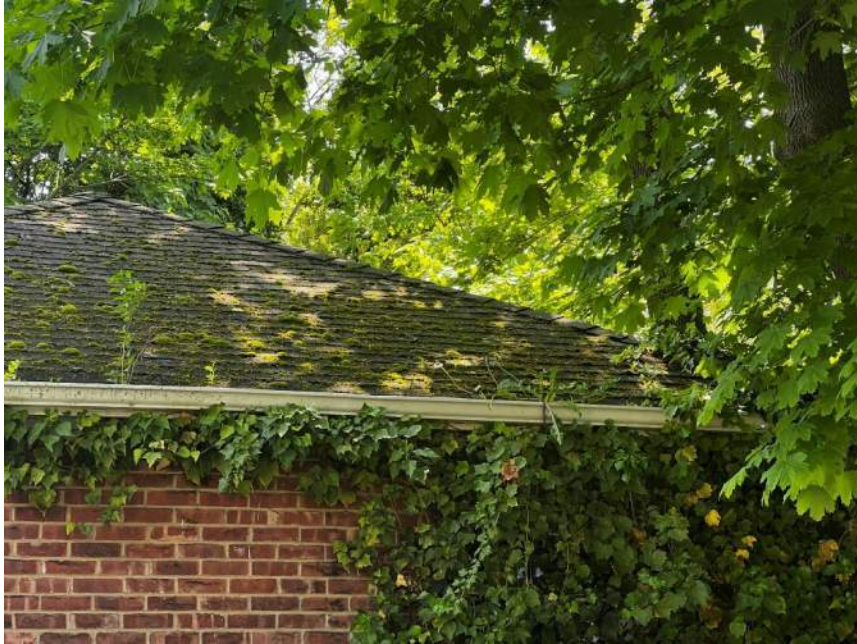
PHOTO 19: IMG_1412 – North Side Roof - Visible moss on roof structure.
